***AMSTree***

## **CEDR TRANSNATIONAL ROAD RESEARCH PROGRAMME**

### **D3.1 Report outlining current assessment techniques and identifying opportunities how to incorporate new data streams in condition assessment.**

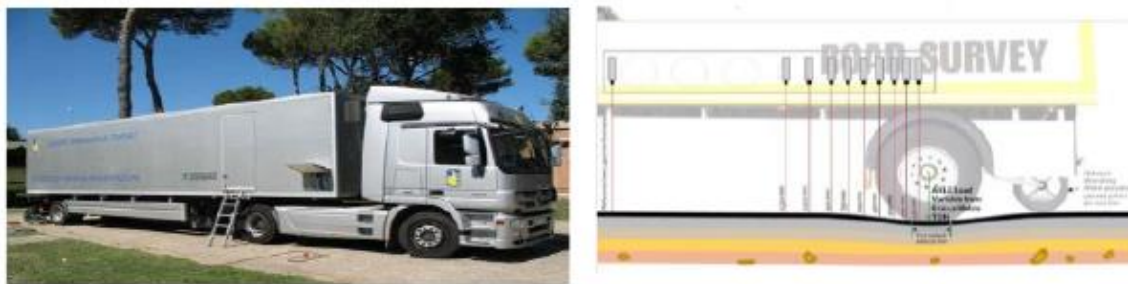
**Figure 2** a) Traffic Speed Deflectometer (TSD) vehicle and b) the layout of its lasers, after Wright et al. 2016)

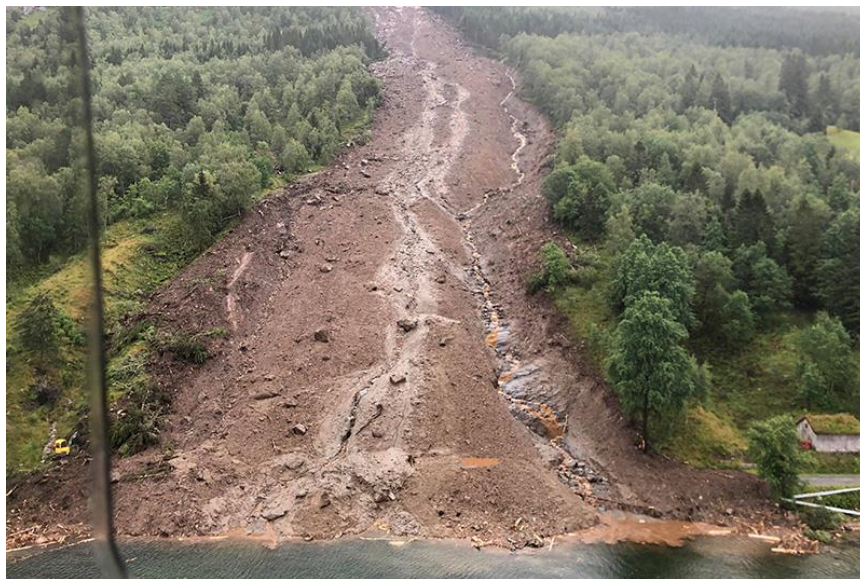
**Figure 3** Rainfall induced landslide inundates road at Jølster, Norway  
(Photo: HRS Sør-Norge)

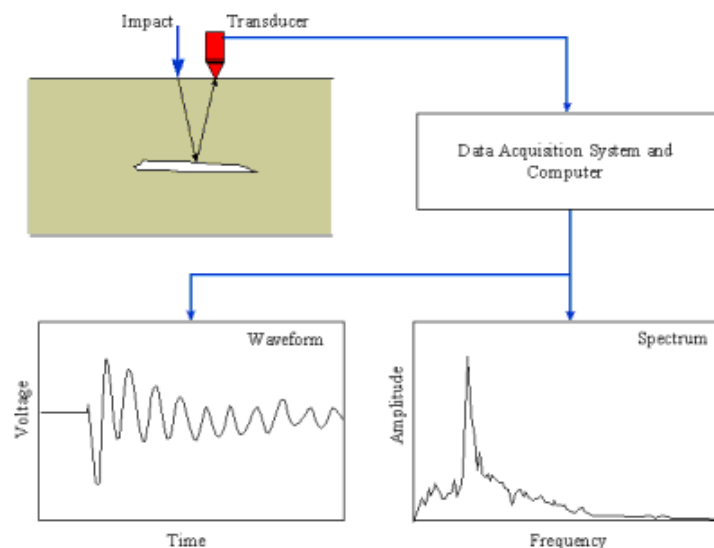
**Figure 9** Impact echo test (after [www.ndt.net](http://www.ndt.net))

The impact-echo method is a non-destructive method for measuring the depth of structural members and concrete road slabs using impact generated stress (Sansalone and Streett, 1998). The surface is struck with a round sphere, and the frequency (Hz) of the response is measured. From this frequency, the depth of the slab can be calculated. If the calculated depth is not equal to the actual depth of the slab this indicates that a defect such as delamination is present (Sansalone 1993) and allows the depth to be calculated (Yehia et al. 2007). The impact-echo method is commonly used on bridge decks to detect abnormalities during routine checks however, it also has applications for flaw detection in highway pavements, buildings, tunnels, piers, dams, seawalls and other structures. The test results also allow three-dimensional maps of a deck to be visualized (Gucunski et al. 2006 and Yehia et al. 2007).

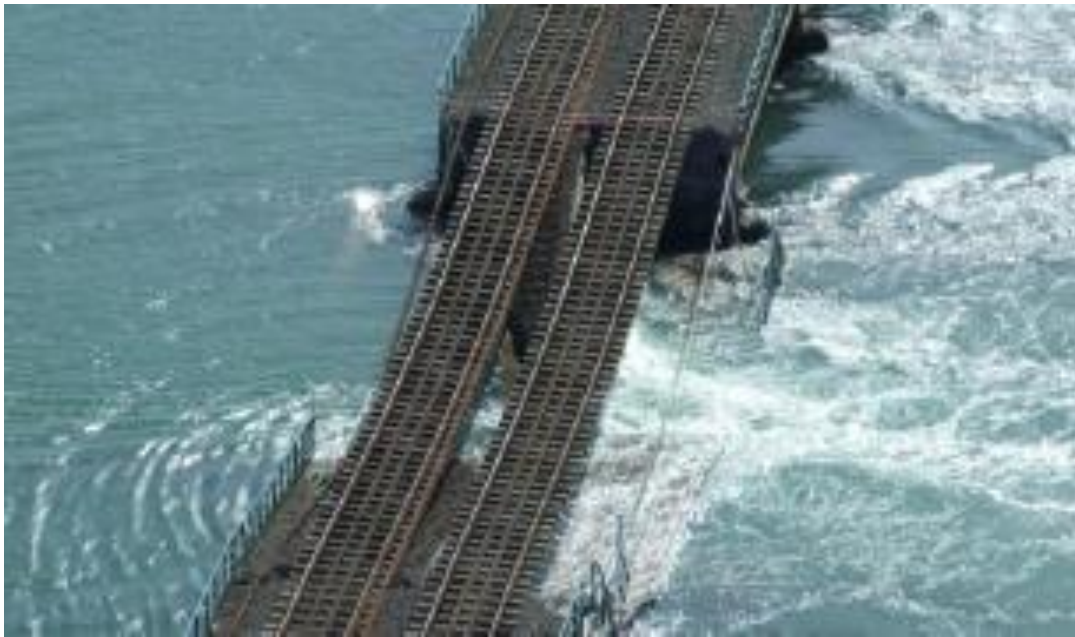
**Figure 15** Collapse of Broadmeadow Estuary Bridge Dublin August 2009  
(image courtesy Irish Rail)

Scour erosion of bridge foundation soil is the number one cause of bridge failure in bridges located over waterways (Forde et al, 1999; Melville & Coleman, 2000; Shirole & Holt, 1991). In the United States, the average cost for flood damage repair of highways is estimated at €42 million per year (Arneson et al. 2012). Scour failures typically occur quite suddenly, with the result that the risk of loss of life is high. **Figure 15** shows the Malahide Viaduct, in North Dublin, Ireland, that failed suddenly as a commuter train passed over it (Maddison, 2012). Fortunately, there were no casualties in this event; however, this section of the TEN-T railway between line between Dublin and Belfast, was closed for several months as a result of the collapse.

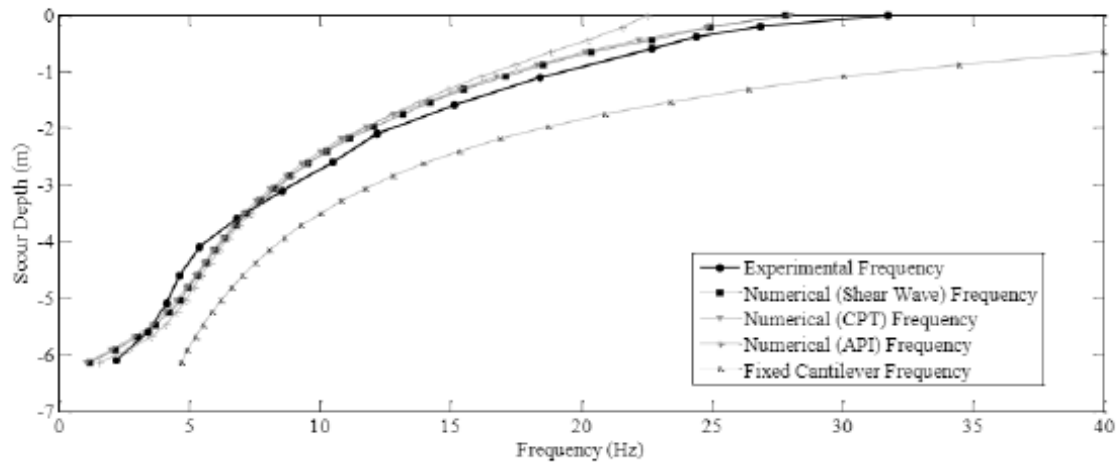
**Figure 19** Comparison of measured frequency with estimate from a numerical model

Based on the field trial the method shows great promise in monitoring scour in real-time.

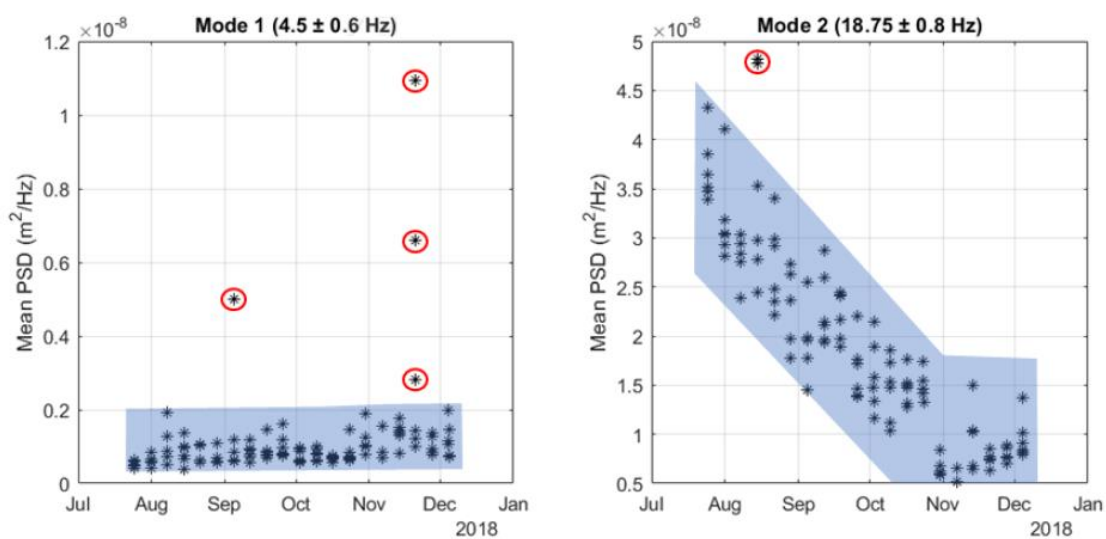
**Figure 22** Mean PSD of vibrations measured on the South Pier of Baildon bridge during scour-hole filling, (from Kariyawasam et al. 2019)

The numerical model suggested that the natural frequency of the bridge would vary between 0.14 and 0.54 Hz during filling of the scour holes. Analysis of the vibration data with a peak picking method and frequency domain decomposition gave a measurement error of 0.6-0.8 Hz. As a result, the resolution of natural frequency measurement was too low. However, there was a clear change in the mode shapes and power spectral density (PSD) of the accelerometer data for Mode 2 (Pier and deck Bending) during the repair phase between August and November, See **Figure 22**. In contrast the PSD of Mode 1 (1<sup>st</sup> sway mode) remains unchanged over the period, albeit with some noticeable outliers.

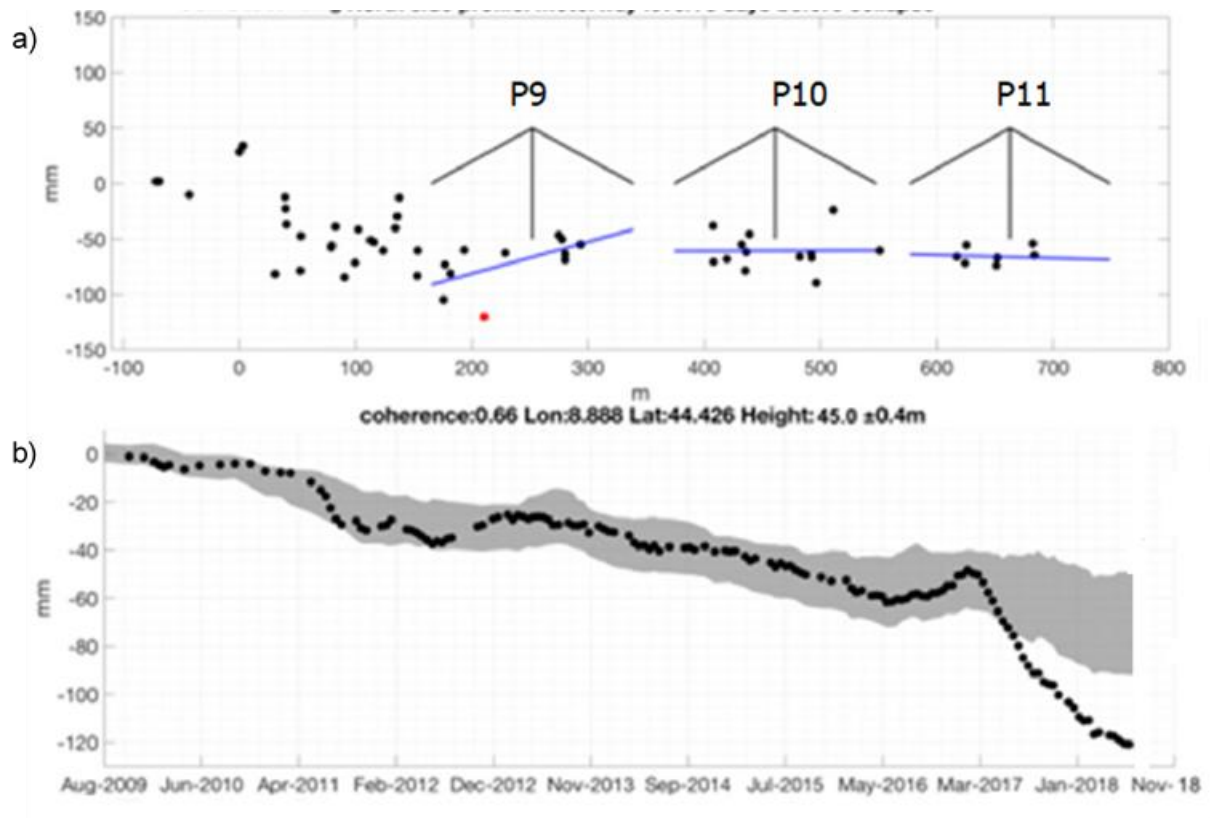
**Figure 30** Time-series deformations on Piers 9,10 and 11 based on CSK/Sentinel 1 A/B satellites from Mililli et al. (2019)

The line of sight data from 2009 until failure was utilized with a Markov Chain Monte Carlo (MCMC) approach to infer 3D displacement fields at Piers 9-11. The data for piers 9, 10 and 11 are shown in **Figure 30a**. At all locations displacements that increased linearly with time (at rates typically below 10mm/yr.). Pier 9 experienced a ten-fold increase in the rate of displacement, See **Figure 30b** in March 2017. The study thus indicated that whilst InSAR data cannot distinguish between stress accumulation and material degradation processes, it could be applied to detect changes in displacement behavior or structural distress of bridges.

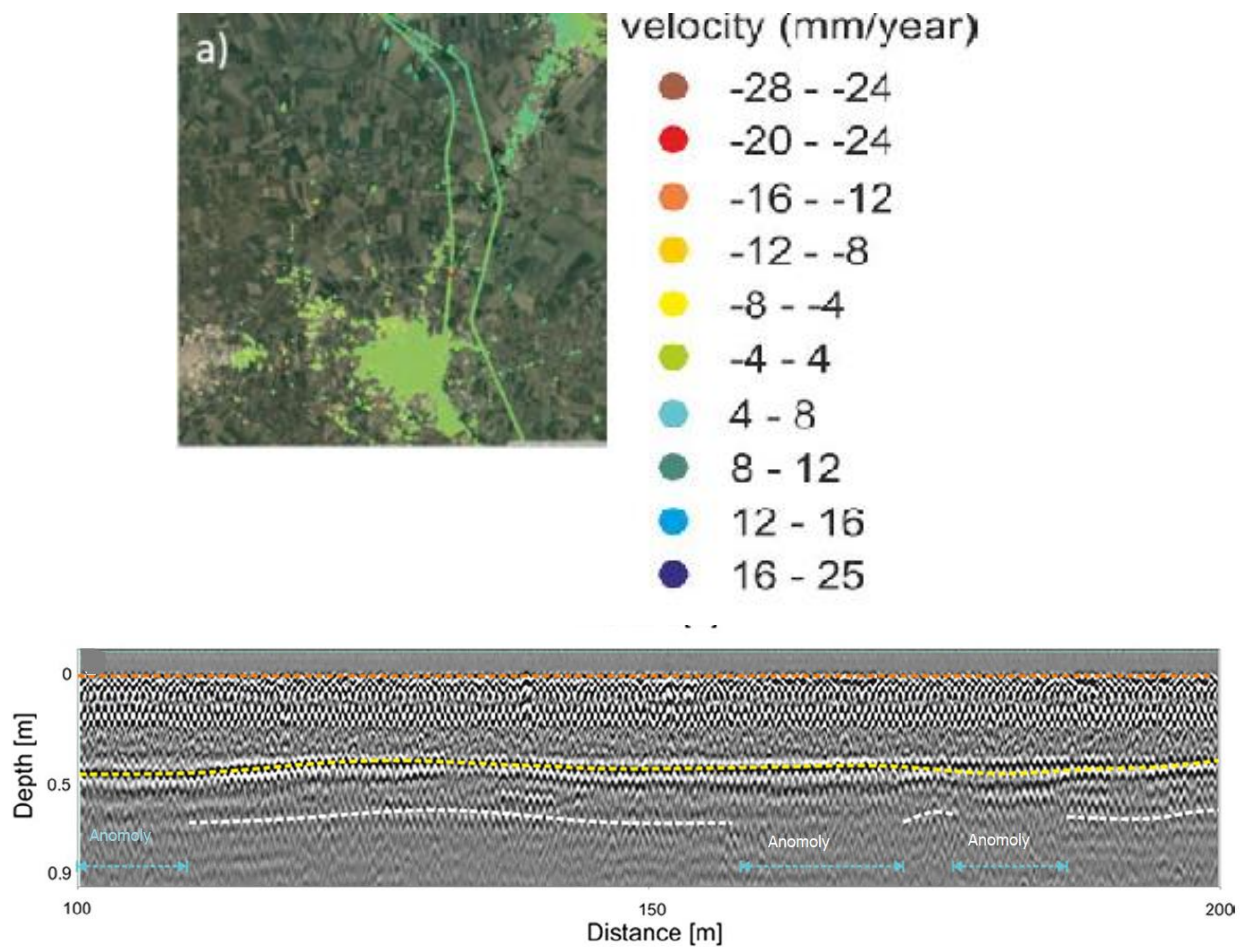
**Figure 34** Data fusion of InSAR and GPR to locate and investigate subsidence on an Italian Rail line (Ciampoli et al. 2020)

Because laser scanning cannot give information on internal degradation processes, Biancini-Ciampoli et al. (2020) propose the data fusion concept of combining Synthetic Aperture Radar (SAR) data with GPR to infer information about the material forming the structure. They performed a field investigation on a 9.8km section of the railway line in Foggia, Southern Italy. GPR acquisition was performed using a train mounted, multi-frequency antennae (1000 MHz and 2000 MHz). The InSAR data were collected by the Sentinel 1A mission between April 2017 and January 2018. The interpreted data revealed one location (red point in Figure 34a) where the displacement rate was in the range 20-24mm/yr. The GPR survey identified a number of high attenuation areas, associated with clayey, compressible materials in this area.
