## CEDR 2018 Noise and Nuisance - Final Conference

### WP 3: In-Situ Inspection Tools

#### D3.1 – Final report on the main results of WP3 (including M3.1, M3.2 and M3.3) – In-situ inspection tools

# To what extent can in-situ inspections yield meaningful indications on the acoustic performances of noise barriers?

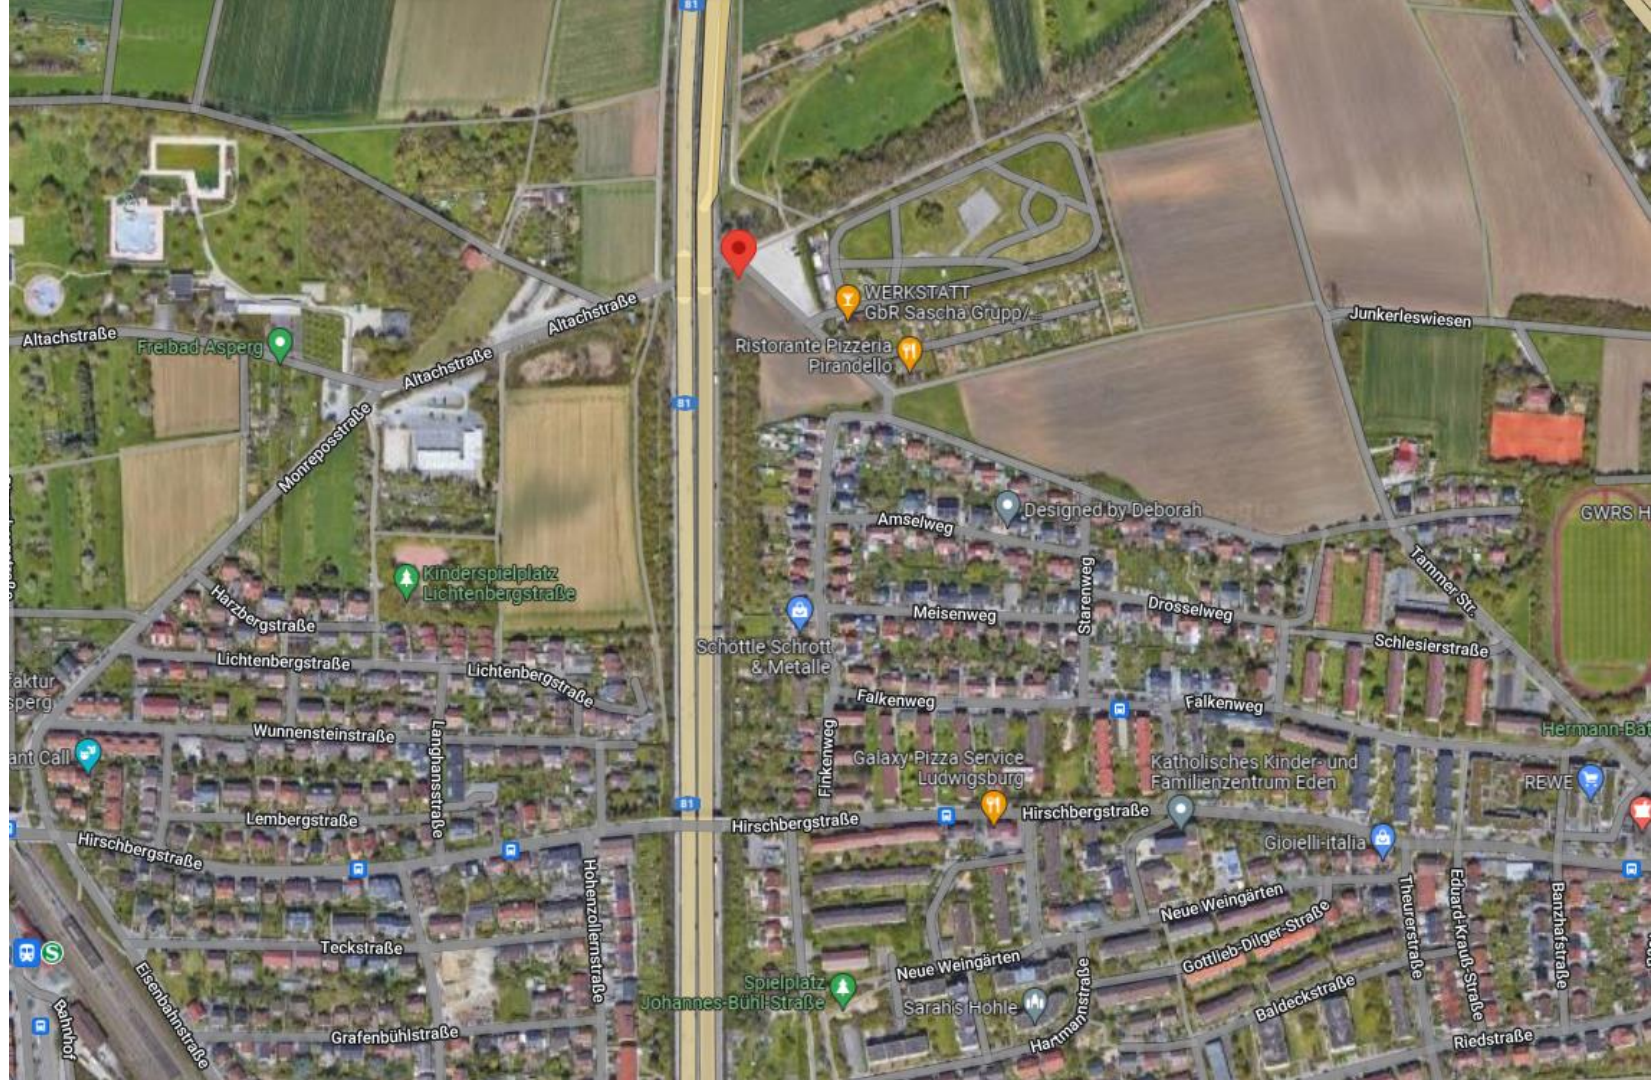
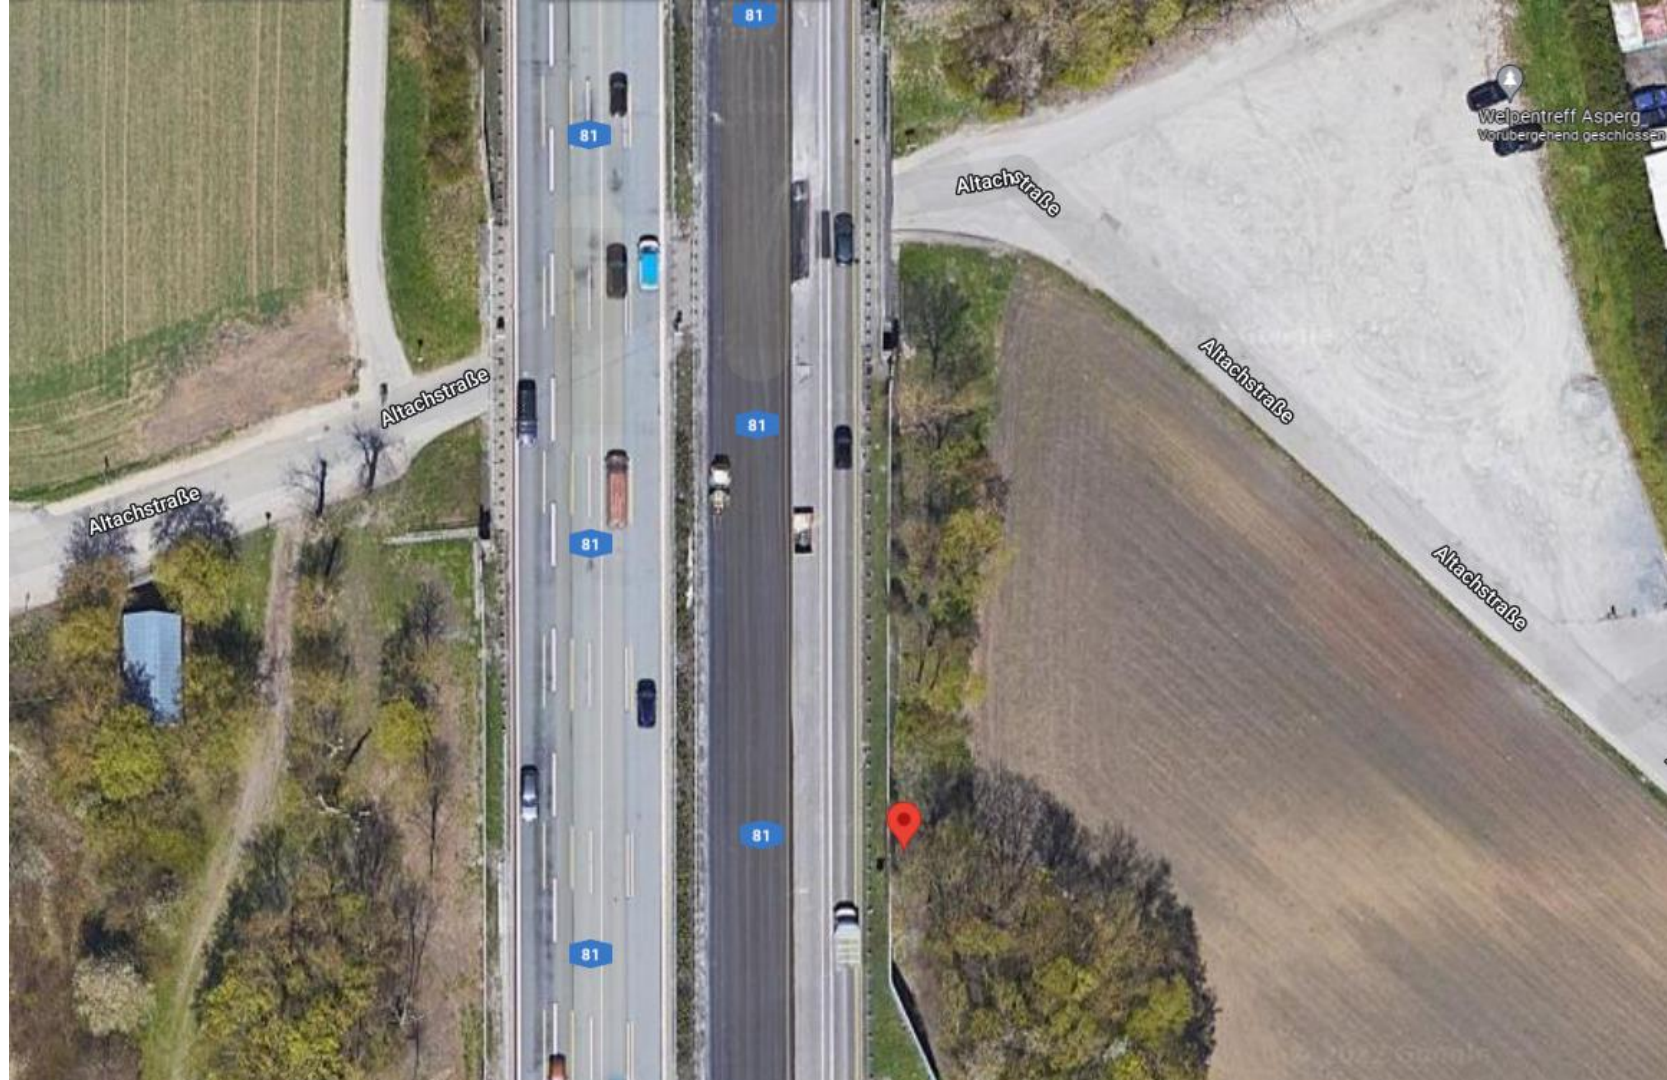
①

Asperg

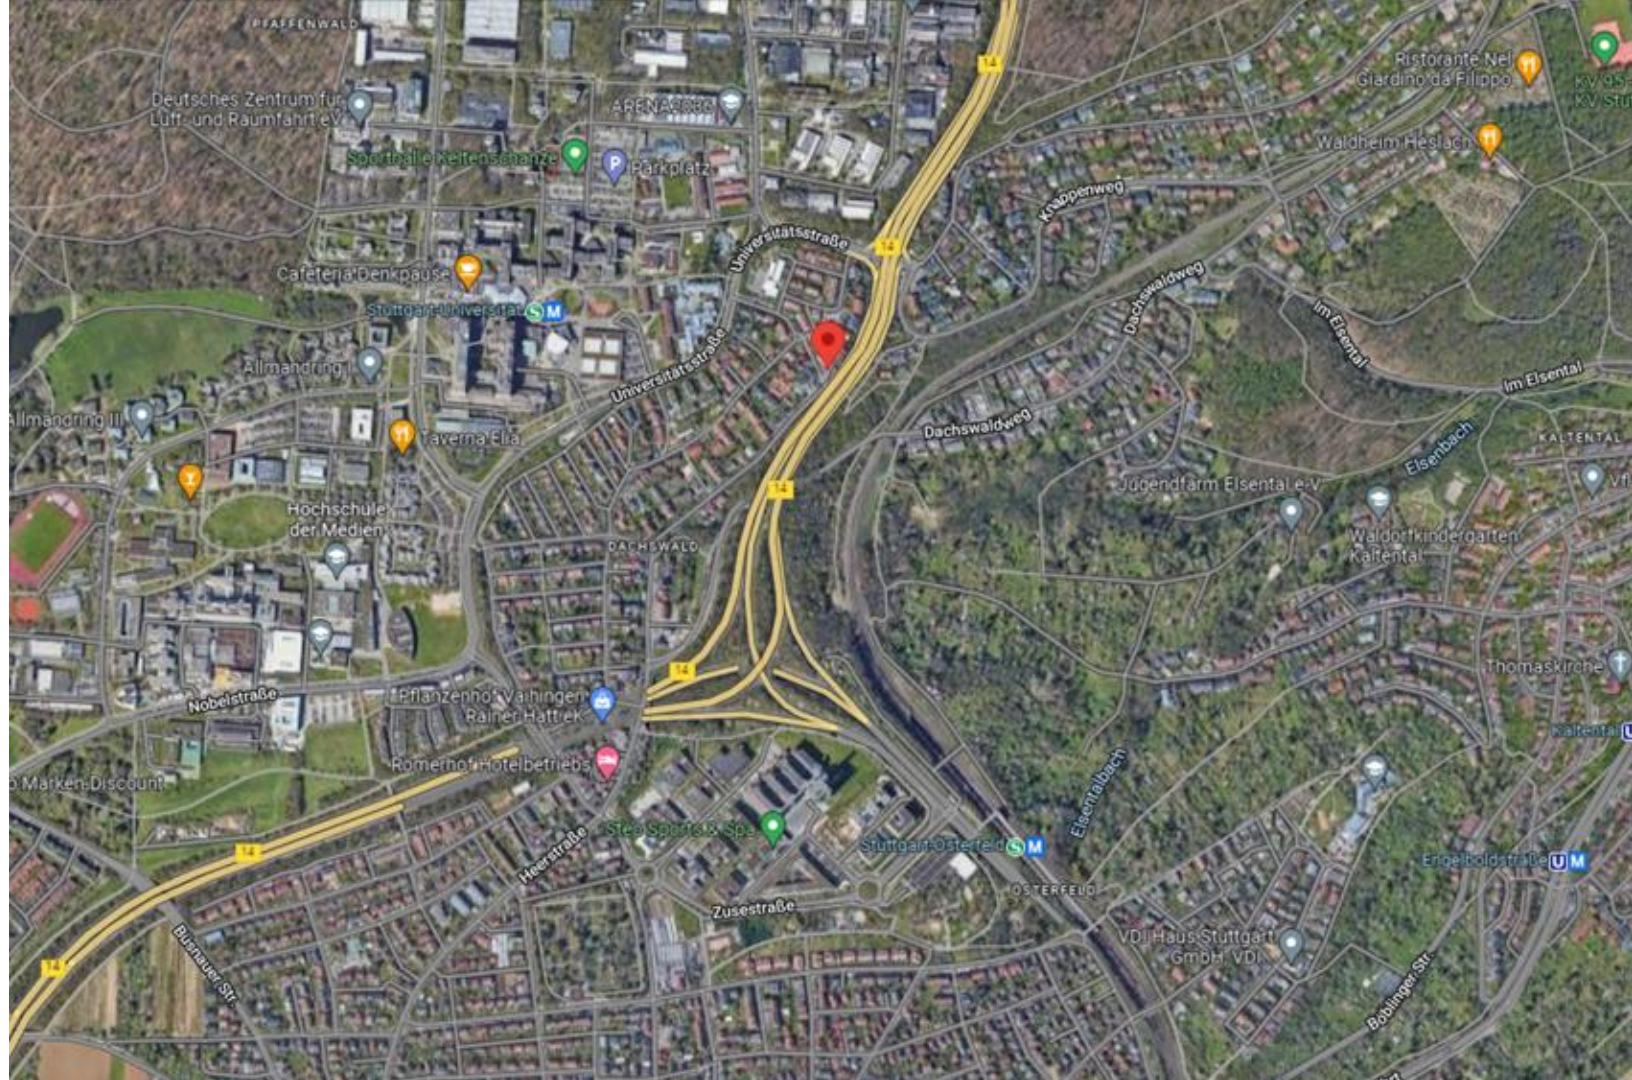
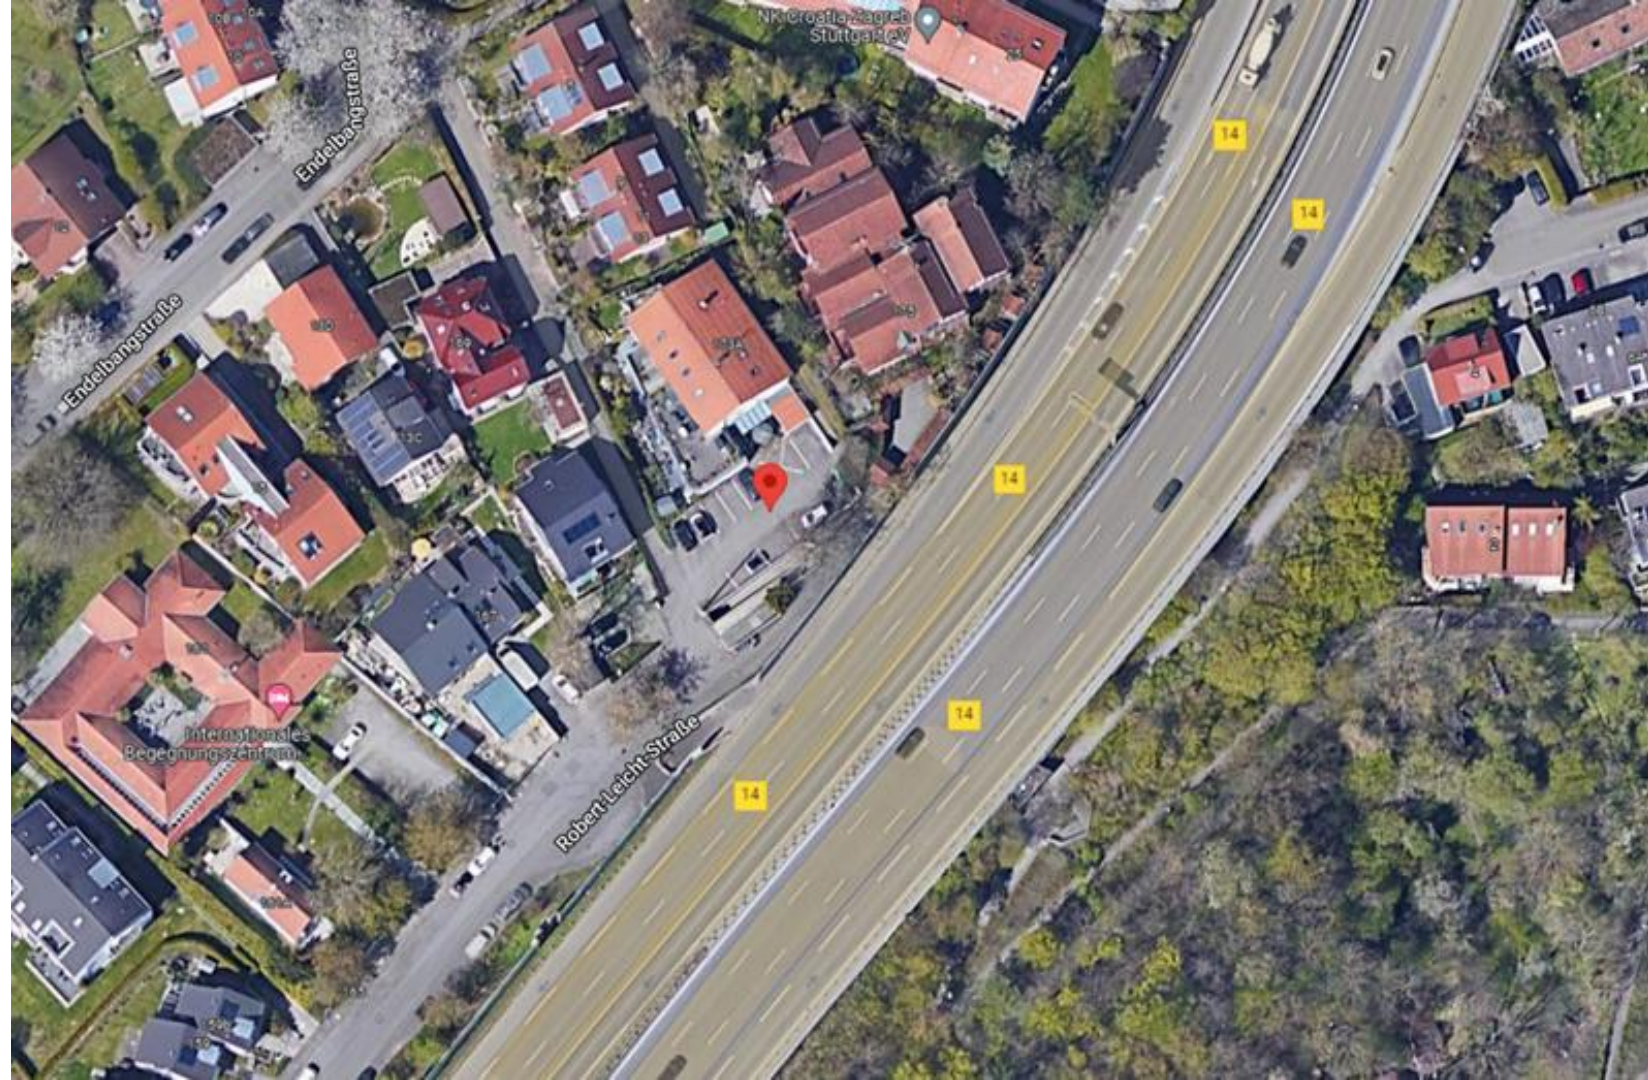
②

Inspection location:  
B14 near Vaihingen, direction of Sindelfingen

Noise barrier material: concrete with and ---.

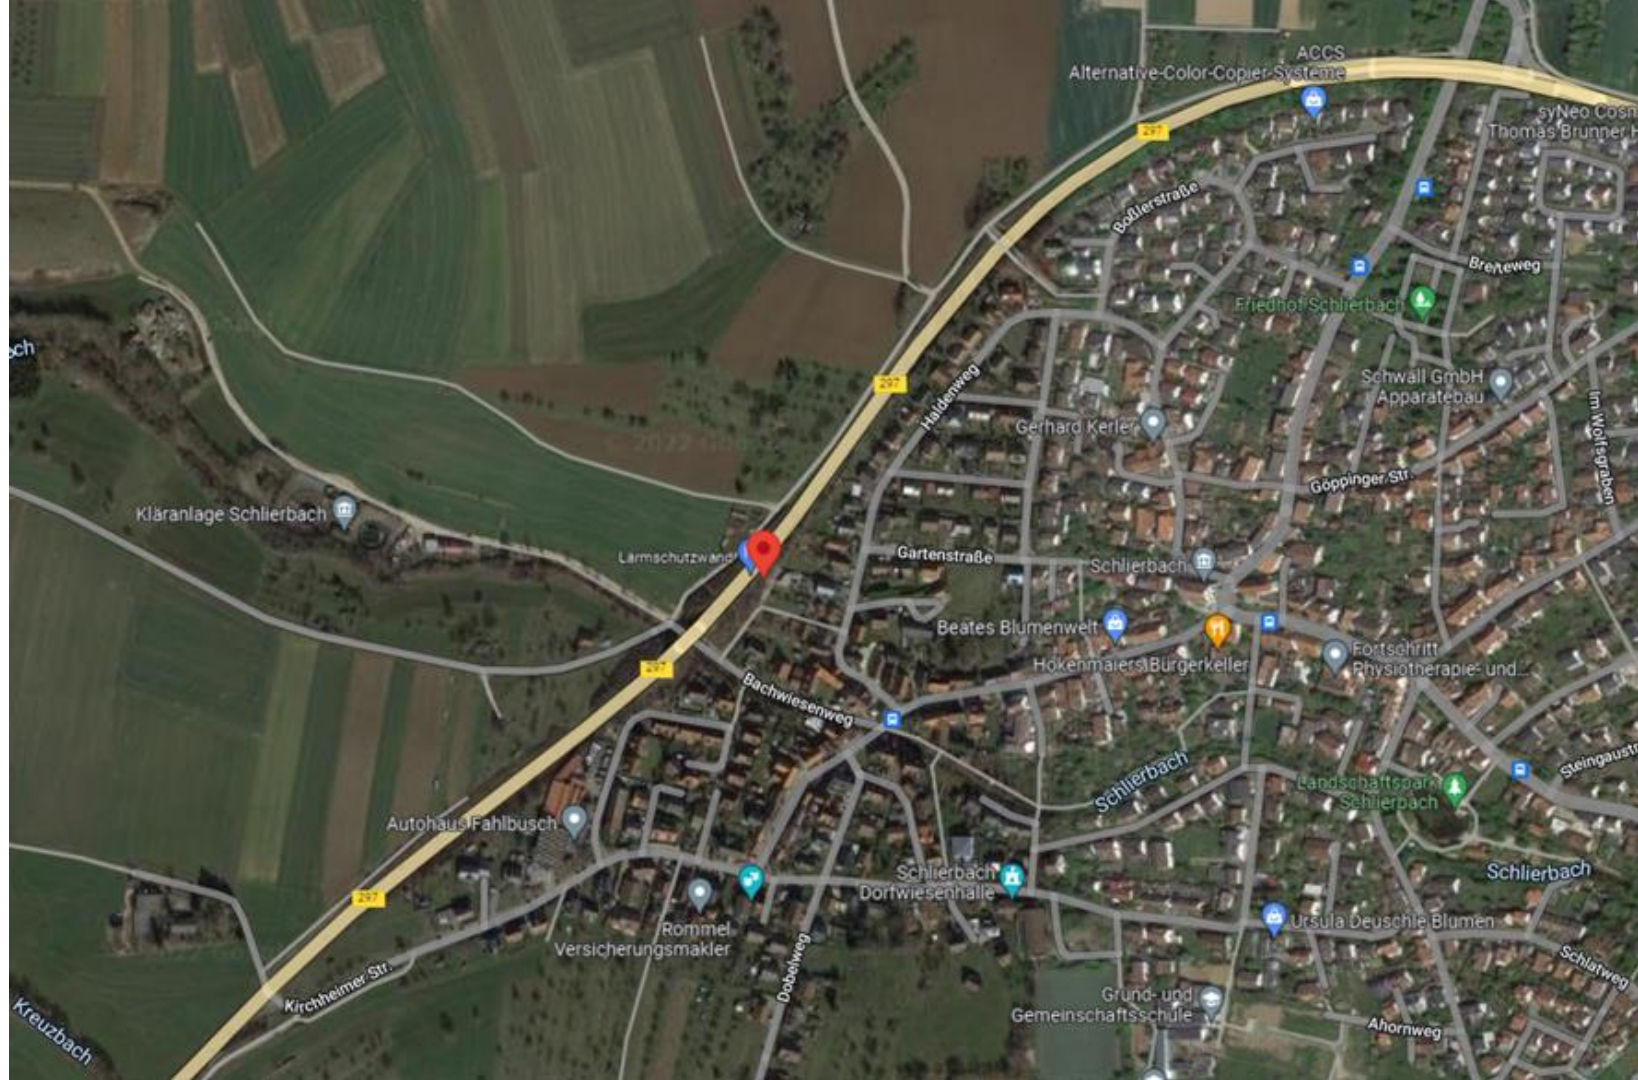
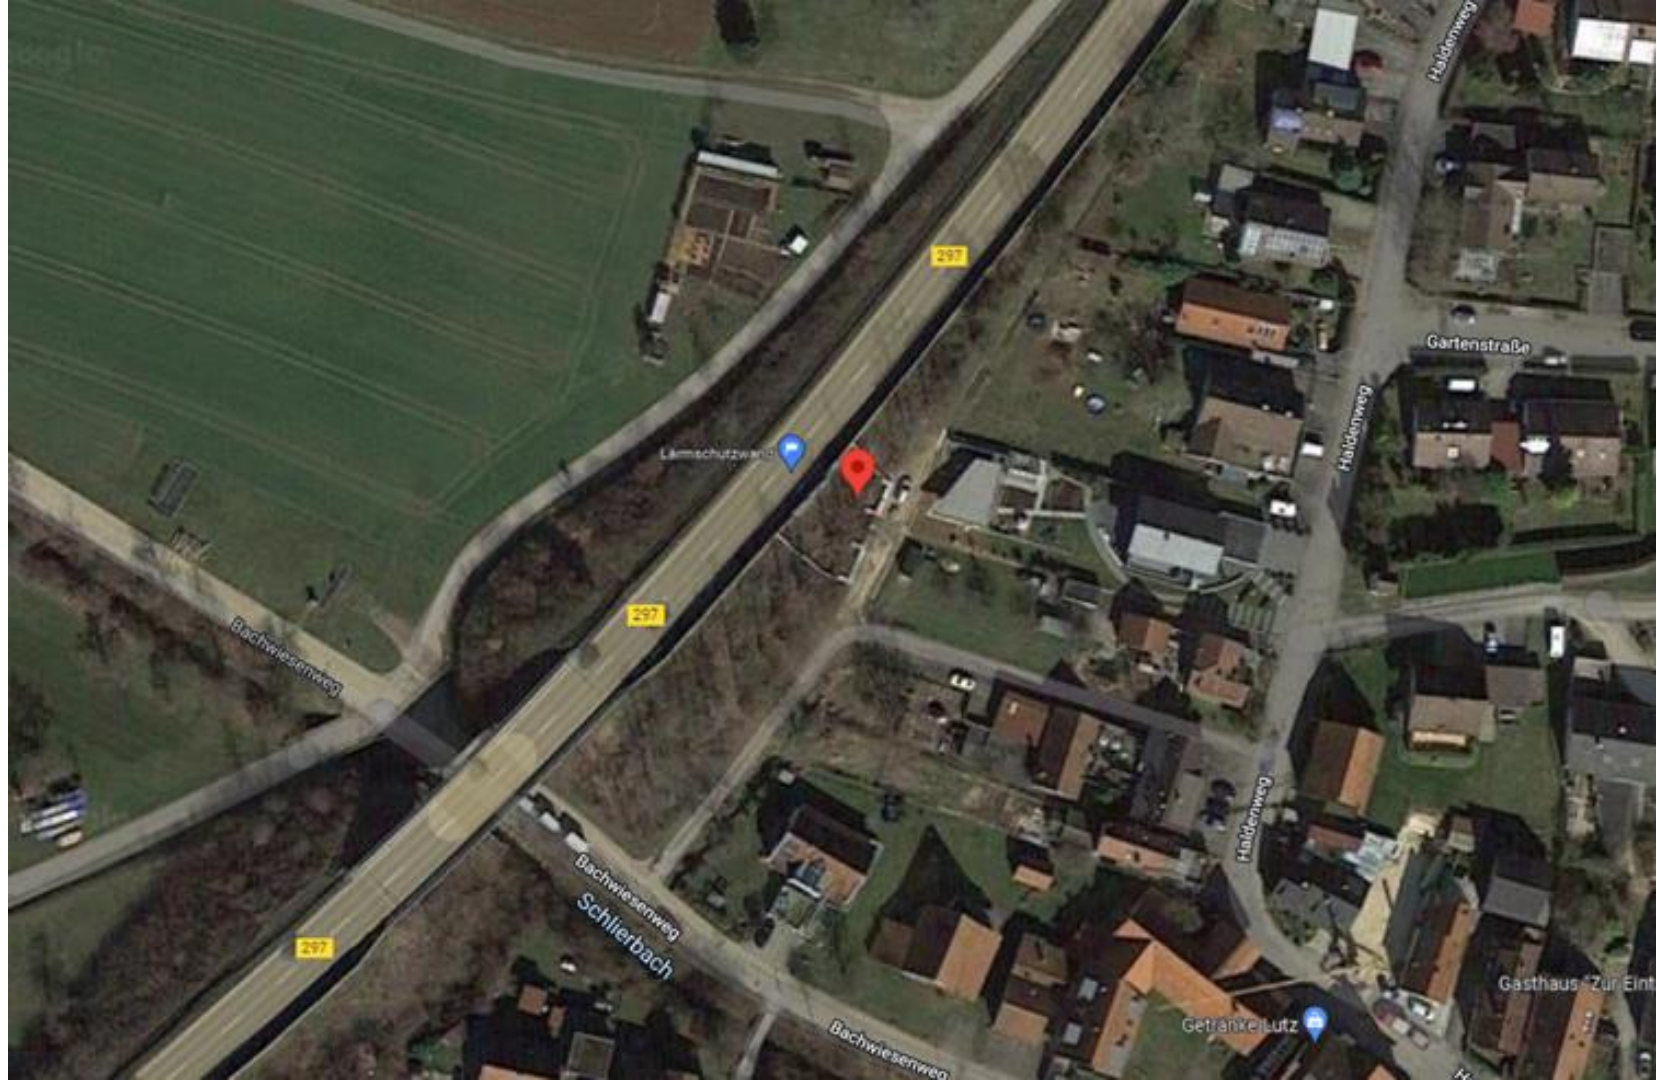
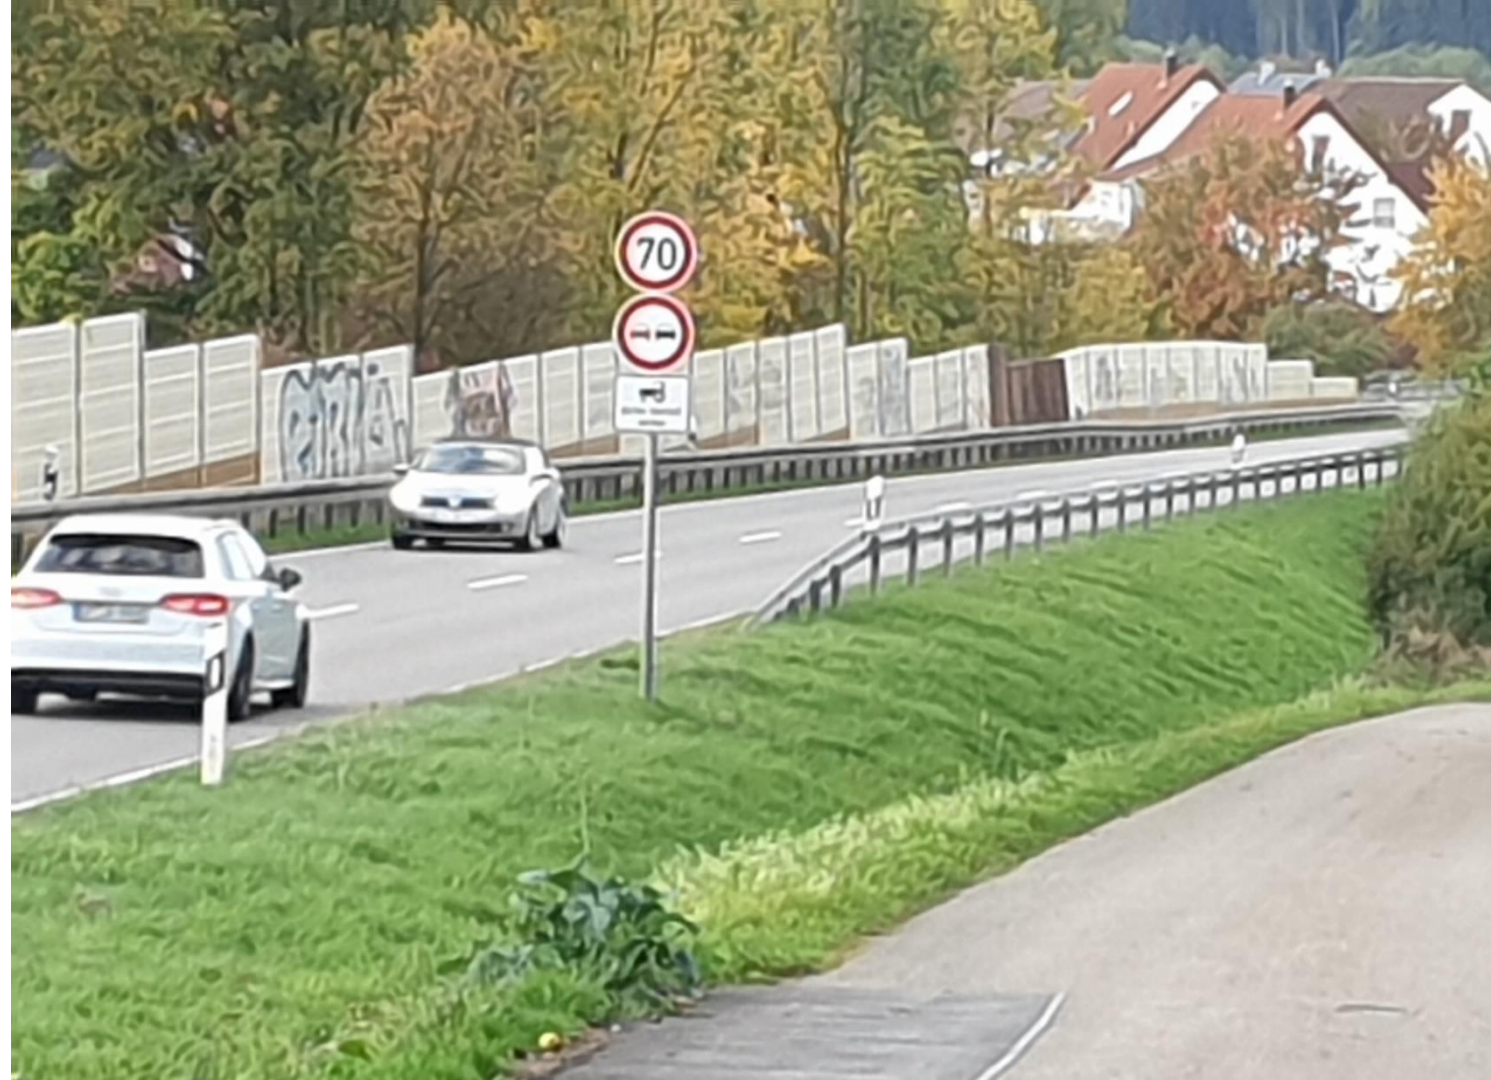
③

Inspection location:  
B297 near Schlierbach, direction of  
Albershausen.

Noise barrier material:  
aluminium with aluminium and ...
