# INFRACOMS

Innovative and Future-proof Road Asset Condition Monitoring Systems

## Case study catalogue

Deliverable D4.1

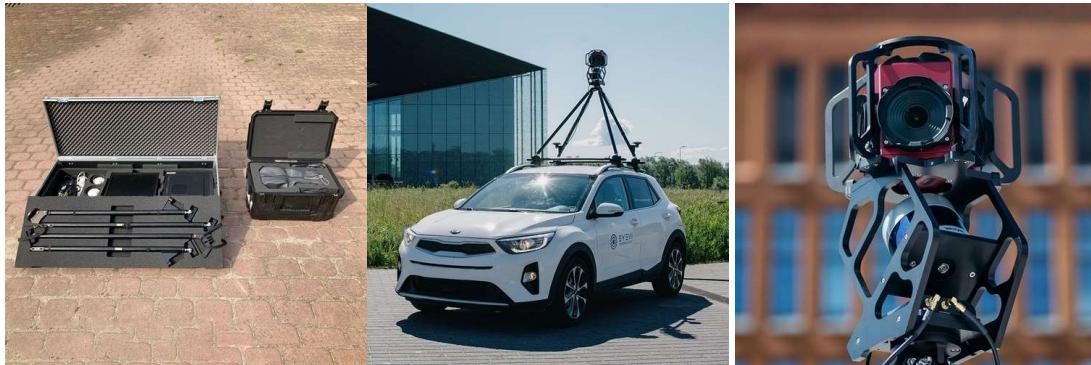
Figure 3: EyeVi hardware and sensors.

- **EyeVi Hardware and Sensors (see Figure 3):** EyeVi utilises vehicle-mounted equipment, including a 360° panoramic camera, LIDAR scanner, and a navigation system sensor. The system is portable and easy-to-setup by the client.

- **Specifications:** The system typically captures images every 3 meters, has a data gathering speed between 50-70 km/h, operates between -10 to +50°C, and stores data on an SSD in a field computer.
- **EyeVi Data Capture** is fieldwork software designed for effective data collection (see Figure 4). It manages the collection of GNSS/INS data, LIDAR data, and raw panoramic camera imagery. Drivers can start and stop data collection, and the software also provides real-time feedback on data quality, as well as showing the panoramic images and visualising the driving trajectories on a map.

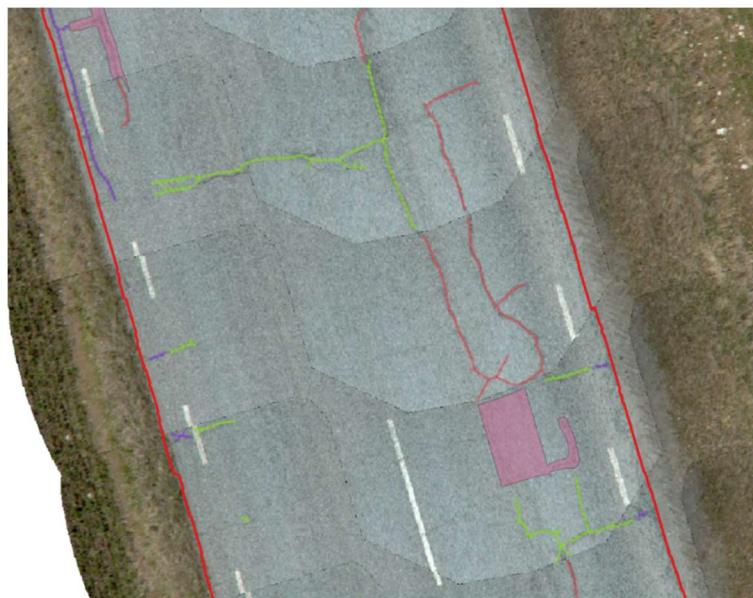
*Figure 5: Identification of road defects using AI.*

- **Road Defects:** The AI identifies road defects and attributes using ortho imagery (see Figure 5). It can detect various types of road defects, such as cracks, network cracks, patches, etc.

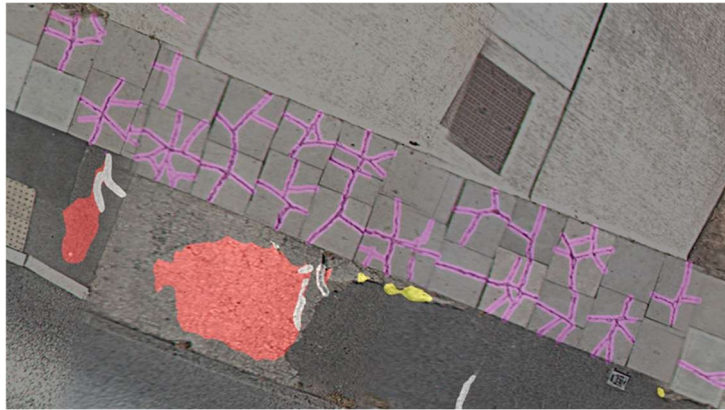
*Figure 6: Identification of sidewalk defects using AI.*

- **Footway Defects:** Using ortho images, the AI can detect issues such as cracks in sidewalk plates and other anomalies that might pose challenges for pedestrians (see Figure 6).

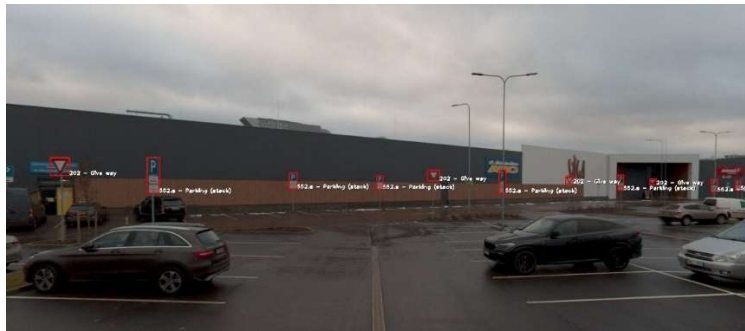
*Figure 7: Detection of roadside traffic signs*

- **Traffic signs:** Panoramic images are used to detect and localise roadside traffic signs along with their type (see Figure 7).

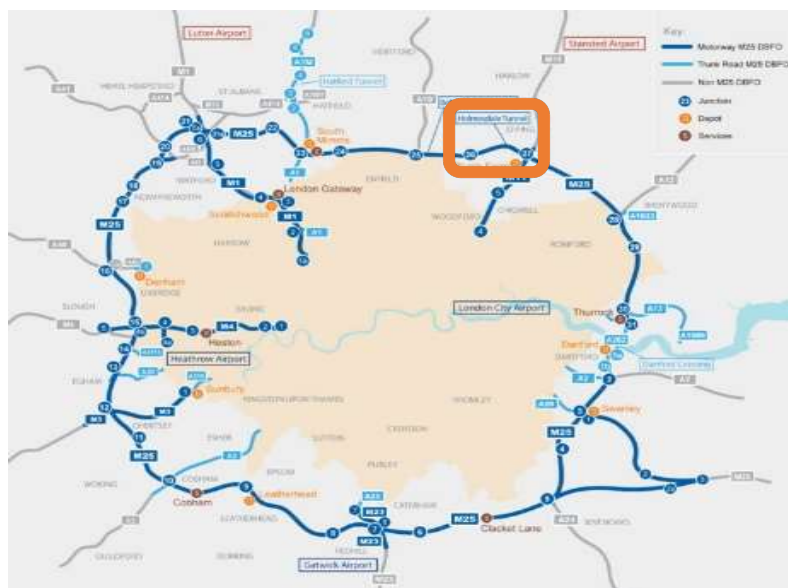
Figure 13: Connect Plus M25 Network with study area flagged.

The M25 between Junctions 26 and 27 NE of London sits on London Clay, which is prevalent in the region. The section of road investigated was approximately 3.35km west of Junction 6 prior to the Holmesdale Tunnel (51.689039, 0.083664). The M25 is part of the English SRN and is managed under a 30-year PFI contract let by National Highways (NH) in 2009 to Connect Plus. Completed in 1986, it forms 125-mile orbital route some 20 miles from the centre of London and is one of the heaviest used roads within the UK.

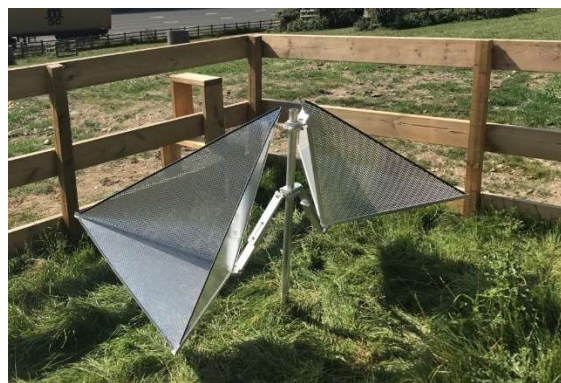
Figure 18: Satellite reflector dish types.

A set of baseline points utilising a reflector dish in conjunction with a traditional reference point in a safe location is recommended to validate sites. The verification site doesn't need to be directly next to the area under investigation – it can be in a safe adjacent site. As noted above, where reflector points are installed, see Figure 18, a single point can be generated for accuracy checking.

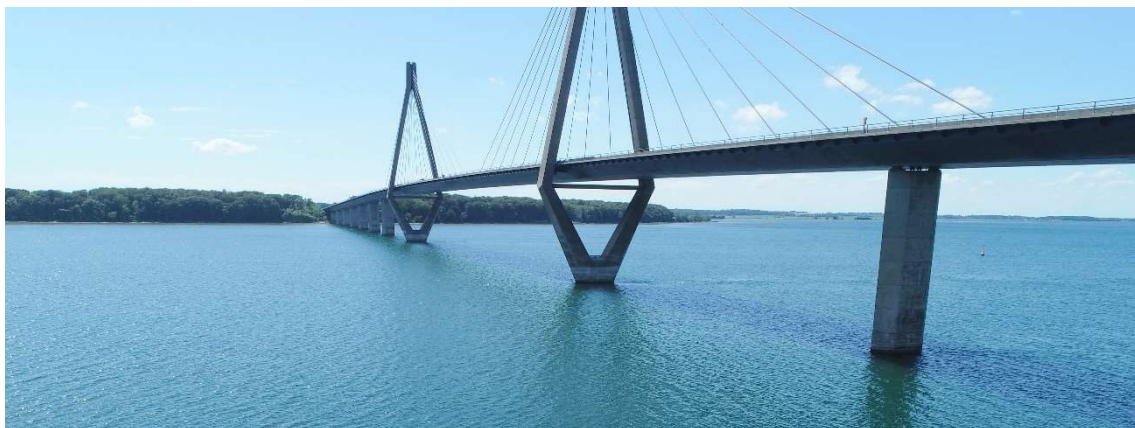
Figure 19: The Farø Bridges. Cable-stayed bridge.

Traffic lanes: 4 (vehicles)

Height of pylons: 94.14 m above sea level

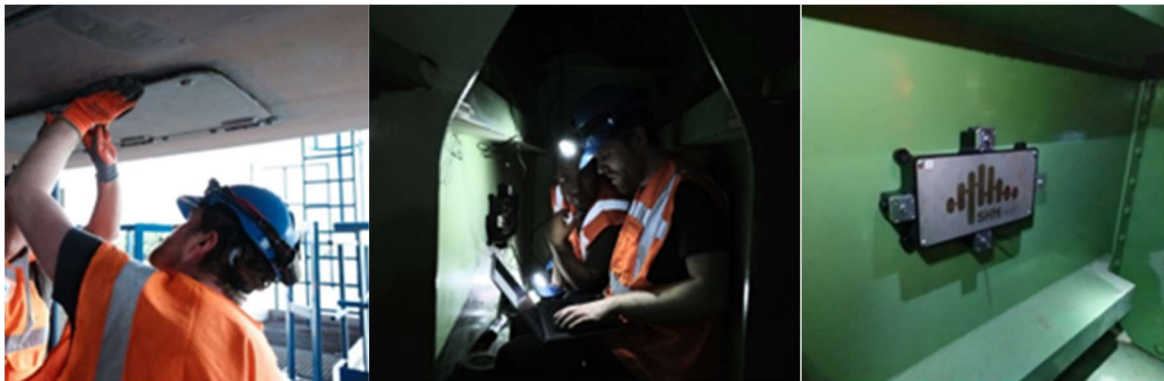
Figure 25: Installation of the sensors UniQ on the bridge.

The monitoring campaign included a total of three monitoring periods (Figure 26), each having a duration of 2 months. The scope comprised of identification of the location of possible defaults in a section of 45m of the girder (3x parts of 15m), as well as 4x rivetted connections in the section. Each part (15m in length) was monitored using 5x sensor nodes (i.e., UniQ).

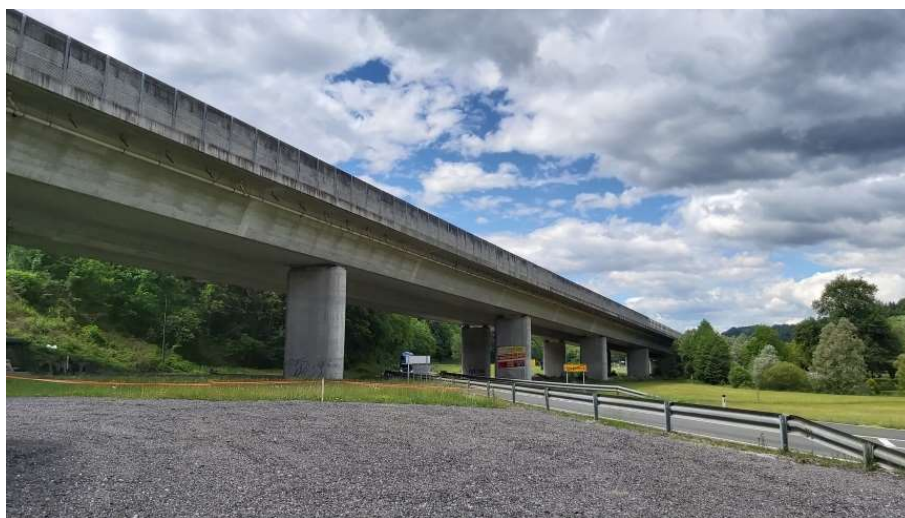
Figure 28: Multi-span highway viaduct – side view.

Both viaducts share a symmetrical structural scheme. Their superstructure consists of continuous box girders, incorporating internal prestressing tendons and external tendons outside the box girder walls, whose purpose is to carry the traffic load. Each of the twin viaducts was erected using the incremental launching method. The left structure encompasses ten spans and stretches 427.6 meters while its counterpart on the right spans a slightly longer distance of 447.6 meters, segmented into eleven spans. Box girders include internal prestressing tendons at the top and bottom flanges and external prestressing tendons which are located inside the midspan deviators at the lower bridge deck.

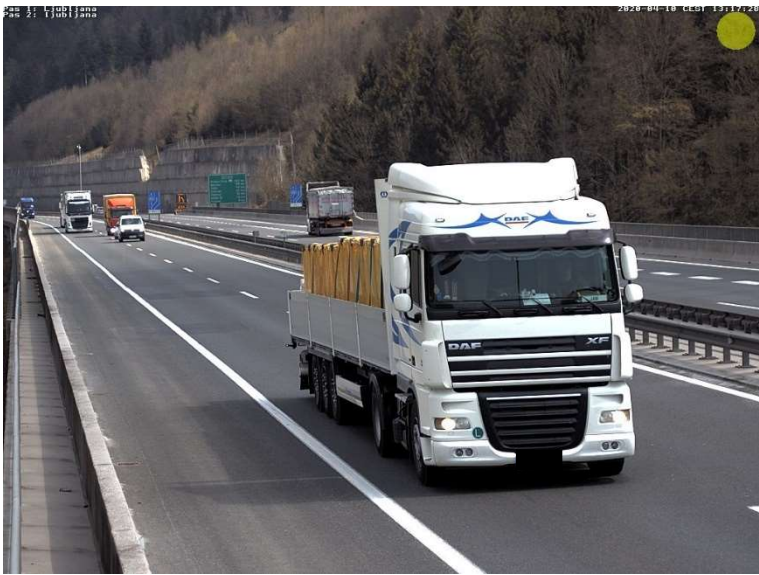
Figure 33: Calibration vehicle.

- **System calibration** - Two 5-axle-vehicles with different axle configurations were used as calibration vehicles. Both vehicles were statically weighed. Their gross vehicle weights (GVW) were 35.0 and 38.2 tons, respectively. Both vehicles crossed the viaduct during the calibration at two transverse positions – in the driving and overtaking lanes. The speed of individual runs ranged between 79 and 89 km/h. Altogether, 33 vehicle crossings were recorded. During the calibration, no other vehicles were present on the viaduct.
