## **Speed management at Work Zone - Field studies and stakeholder's survey**

Deliverable 4.1

### **ASAP**

## **Deliverable 4.1: Practical information from field studies and stakeholder's survey**

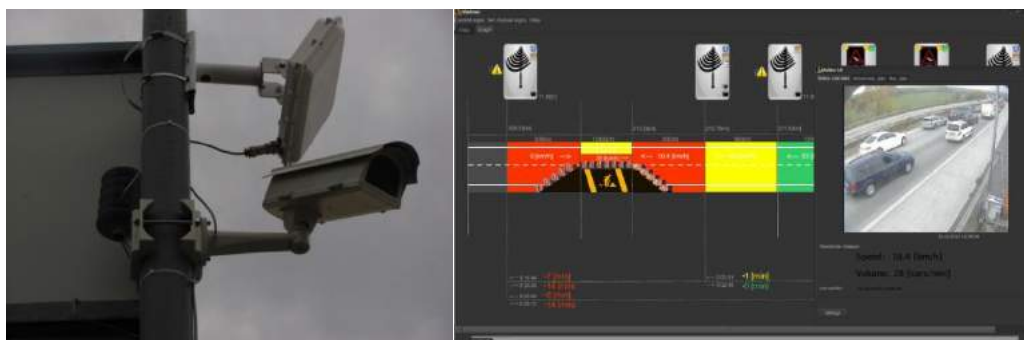
**Figure 3:** Portable traffic detectors (left) and controlling software of portable control system ViaZONE, which was developed and pilot tested on motorway D1 in 2013

ViaZONE designed, created and pilot tested a control system that allows smartly managing traffic at lane closures like along road work sites. Calibrated traffic models based on traffic flow measurements were created in the first stages of the system development. Their task was to verify the designed measures in laboratory conditions and to search for possible placement of detection devices and portable variable message signs, whose role is to guide traffic flow and influence drivers' behaviour.

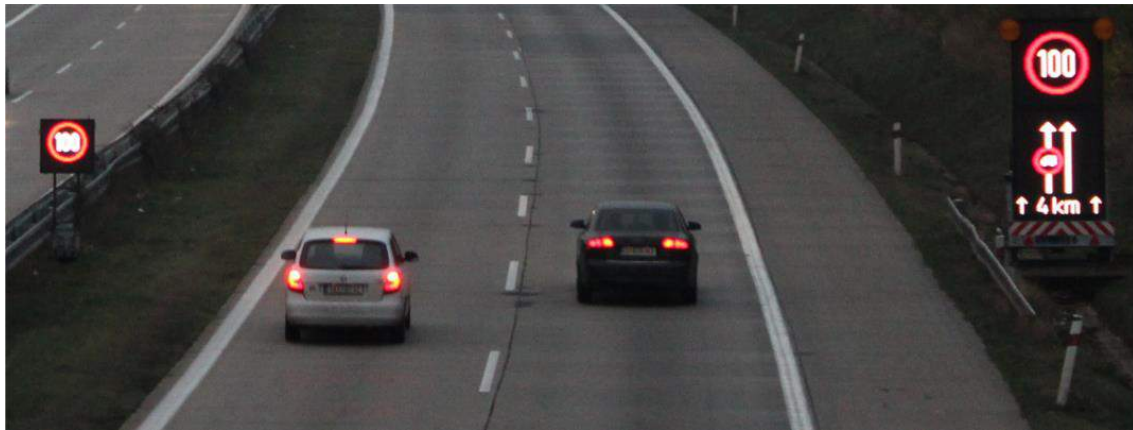
**Figure 4:** Photo from ViaZONE pilot testing

Data from this project showed considerable over speeding; it was found that driven speed was by approx. **20km/h** faster than the speed limit, even at sites where the workers are present and the width of lanes is considerably reduced. This fact is also the main reason for the occurrence of accidents and in some cases a reason for long vehicle queues.

By displaying the road sign B20a (80km/h Speed limit) a reduction of traffic flow speed by **approx. 25% to speed around 100km/h** was achieved. Even better result during the tests was reached by displaying a warning sign A23 “queue” (speed reduced to approx. **95 km/h**). Displaying road sign B20a (100 km/h Speed limit) fails to have an apparent impact on the speed of traffic flow. Certain speed reduction of traffic flow speed was only reached in case a sign “IP21” (Limitations in the lane) was displayed at the lower LED panel on the advance warning trailer (B20a 100km/h is displayed at the upper panel).

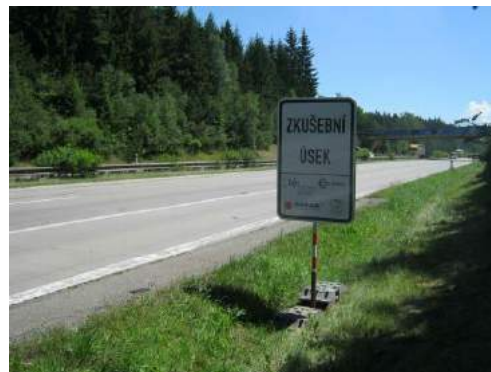
**Figure 8:** D1 motorway in the showcase area and sign informing drivers about the experimentation

Motorway D1 in area of showcase has two lanes in every direction, central reserve. The total width is 26,5 meters and pavement is made from concrete.

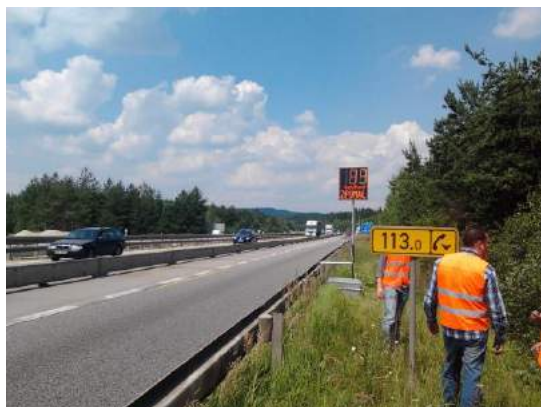
**Figure 9:** Road works cross section and location of the detectors

The road works on the above mentioned motorway section began in March 2014. The traffic was guided into the right traffic lane by a system 2+2 in the direction from Brno to Prague (**Figure 9**). The traffic flow directions were divided by a temporary crash barrier *Protec 100* (**Figure 10**).

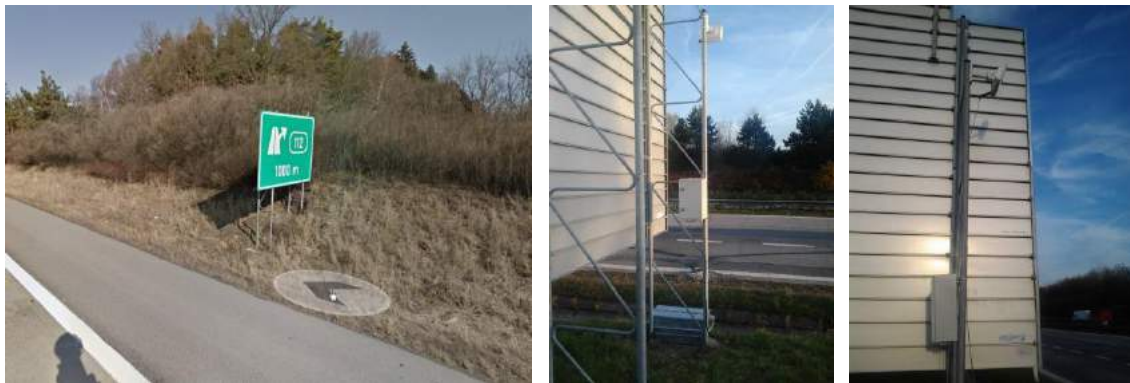
**Figure 13:** Overview of the detection site n°1

The installation was performed on a road sign (**Figure 13**). A battery, which was placed in an anti-vandalism box, was used for the power supply to the detector. The box was fixed to the road sign with a chain. For the installation of the detector, the vehicle was parked in the hard shoulder, while the biggest part of the vehicle was parked on grass next to the hard shoulder. The vehicle was equipped with a beacon.

- 0 – Right traffic lane Prague bound (350 m in front of the transition area)
- 1 – Left traffic lane Prague bound (350 m in front of the transition area)
- 2 - Left traffic lane Brno bound (350 m behind the transition area)
- 3 - Right traffic lane Brno bound

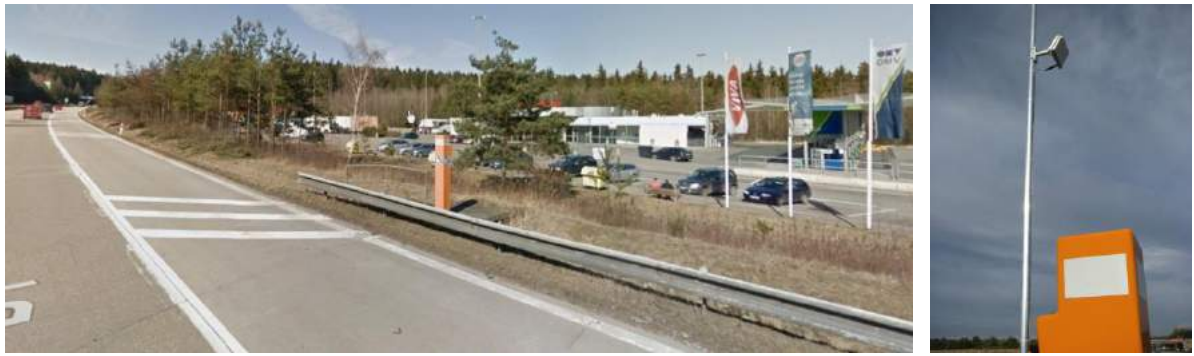
**Figure 14:** Overview of the detection site n°2

The installation was performed on an aluminium post of approx. height of 550 cm. the detector was installed behind the crash barriers (**Figure 14**). The assumed connection to SOS-DIS system with power supply was not conducted, since this system was out of order during its upgrade, therefore alternative power supply from the accumulator needed to be used.

- 0 – Right traffic lane Prague bound
- 1 – Left traffic lane Prague bound

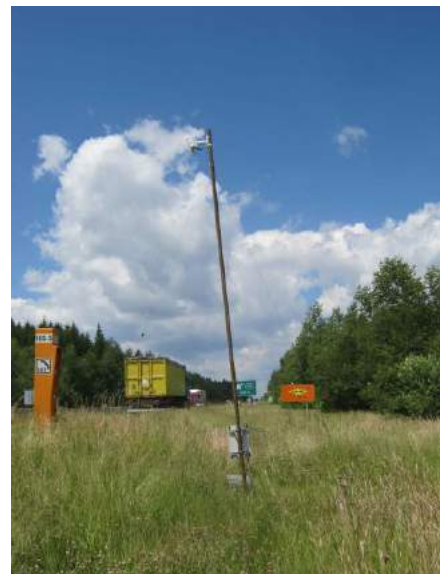
**Figure 15:** Overview of the detection site n°3 and installation of the Wavetronix detector

The installation was performed on an aluminium post of approx. height of 600 cm. The installation was performed behind the crash barrier and the vehicle was parked on an unused parking place, which can be reached by an access from the traffic restricted site Prague bound (**Figure 15**). The access to the “parking place” was protected by guiding boards, between which a vehicle can pass. The assumed power supply from SOS-DIS system was not conducted for the above mentioned reason. The system was supplied from an alternative accumulator power supply.

- 0 – Right traffic lane Prague bound
- 1 – Left traffic lane Prague bound
- 2 - Left traffic lane Brno bound
- 3 - Right traffic lane Brno bound

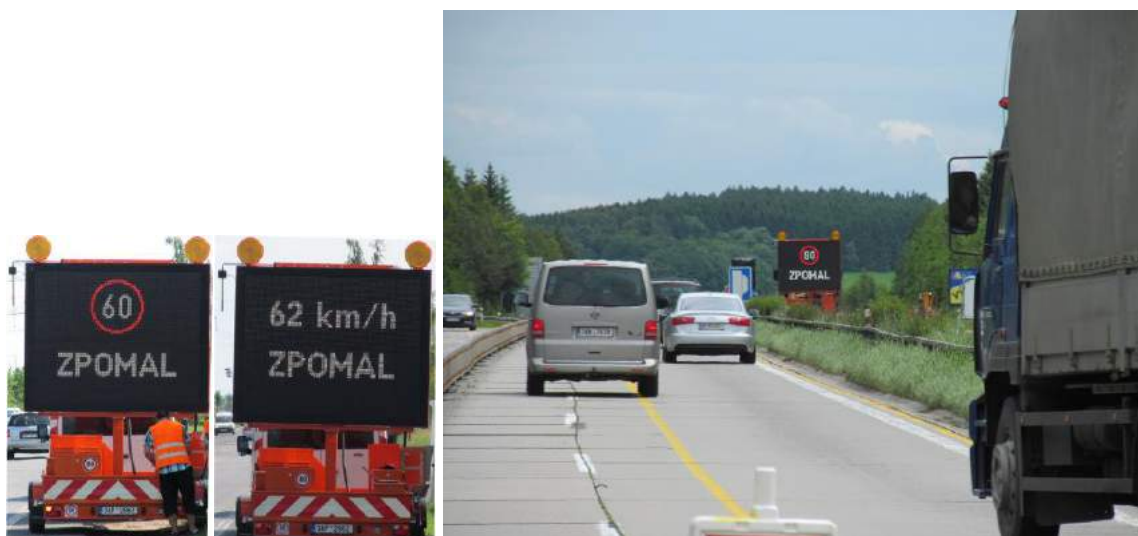
Figure 17: Overview of the information trailer used in the work zone

- Date and time of installation: 5 June 2014, 14:00 a.m.
- Display scheme No. 1 – Beginning 5 June 2014, 14:00  
End 20 June 2014, 7:00
- Display scheme No. 2 – Beginning 20 June 2014, 7:00  
End 30 June 2014, 12:00

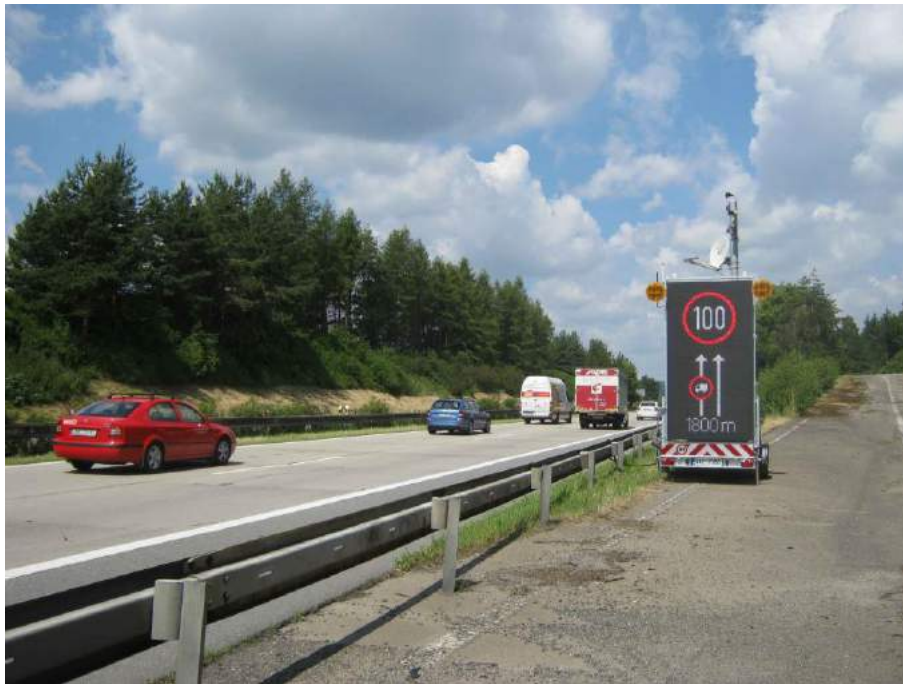
**Figure 18:** Deployment of the LED advance warning trailer

Advance warning trailer LED is used as a replacement of metal advance warning devices. It is possible to use the device for the purposes of variable message signs under condition of meeting road safety requirements (installation behind crash barriers, etc.).

It is designed to reduce speeds in hazardous road sections, to warn drivers of hazards, in case of road accidents, under aggravated road conditions, in congestions, etc., for motorway and dual carriageway repairs and closures. Within the pilot testing of ASAP, this information trailer was used for enhancing road signing in front of the traffic restrictions (**Figure 18**). In addition, two display schemes were used. The advance warning trailer LED was lent by ELTODO, a.s. ([www.eltodo.cz](http://www.eltodo.cz))

- Kilometre: 115.4 km
- GPS localization: 49.435977, 15.644577
- Main impact on traffic data: Station 1, Prague bound
- Secondary impact on traffic data: Station 2, Prague bound
- Distance from Station 1: 1300 m

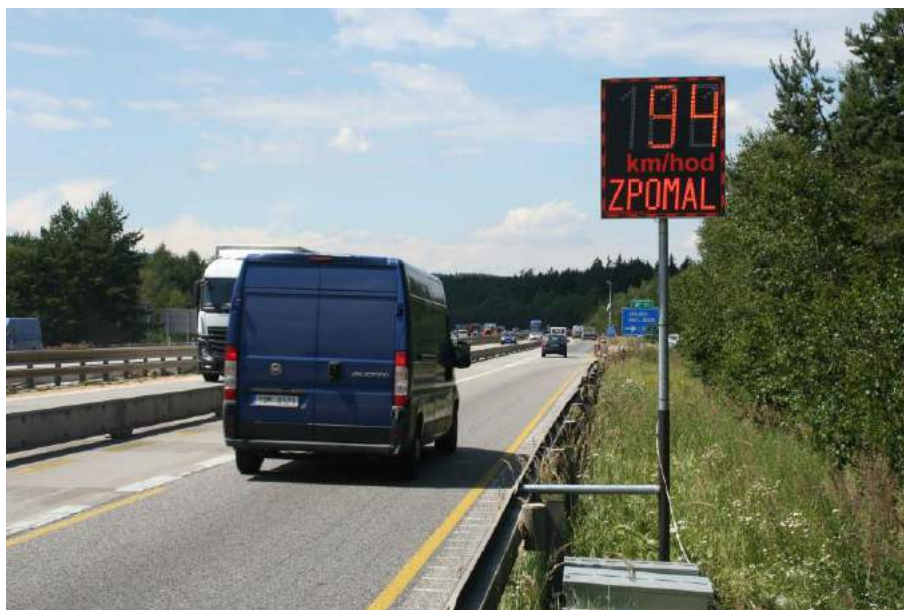
Figure 19: Speed display (94km/h – Reduce your speed)

- 10 July 2014, 12:00 Installation;
- 26 July 2014, 12:00 System uninstalled.

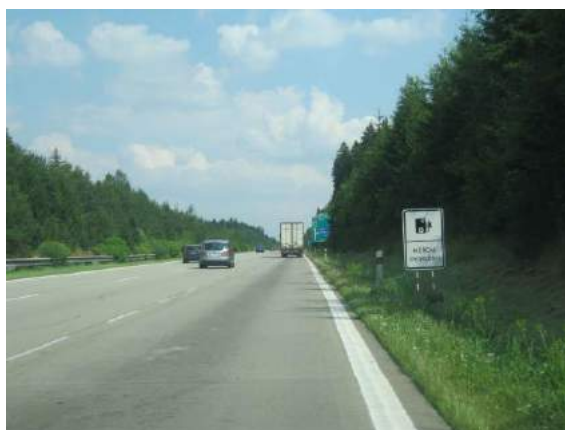
Figure 20: Watch-out sign (speed camera present)

d. Steel structure with a sign “MĚŘENÍ RYCHLOSTI” (Speed camera present; Figure 20)

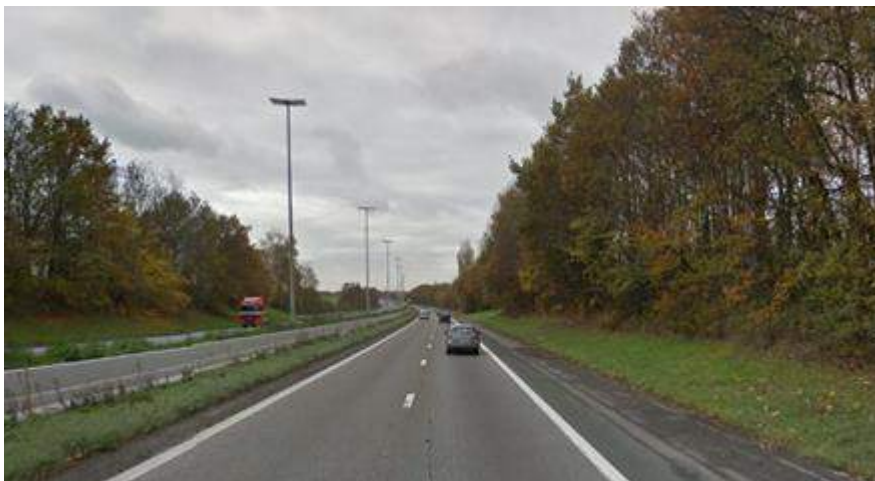
**Figure 25:** View of the A15/E42 (between Daussoulx & Sambreville) before the 2014 works (additional lane to be built on the left side and new pavement to be laid across all the lanes)

The A15/E42 motorway built in the early seventies and composed of 2 lanes (+ a hard shoulder) in each direction is progressively upgraded to 3 lanes (**Figure 25**). The upgrade works (additional lane) between Sambreville and Daussoulx has been achieved in 2013. The 2014 works consist in the same type of operation on the other side of the motorway; giving a 20 km long road work between Daussoulx (around kp 49) and Sambreville (around kp 69) to be executed in 2014 between April and the summer months.

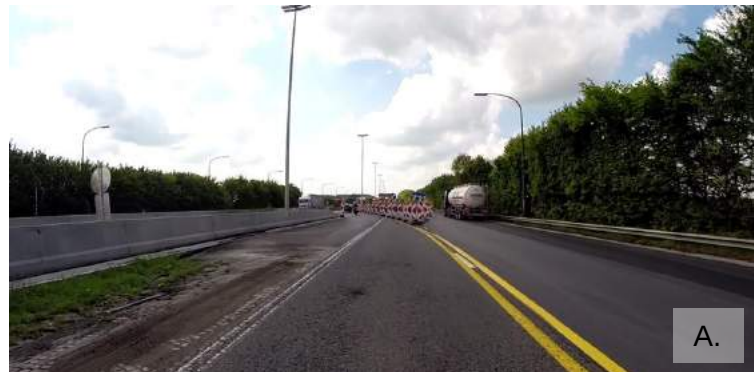
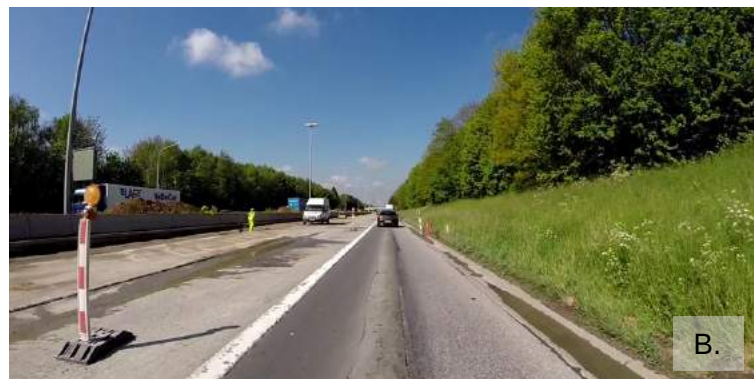
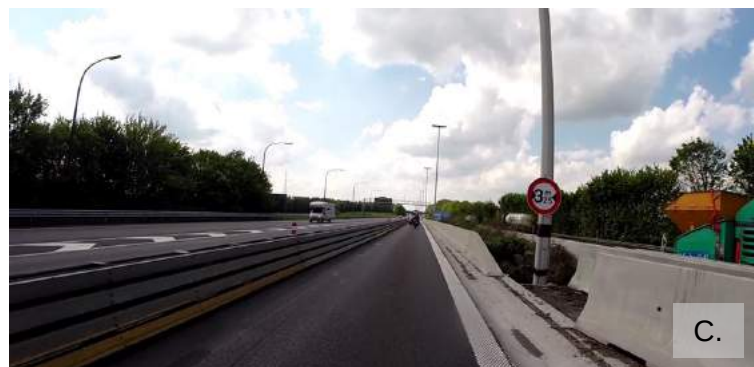
**Figure 26:** Temporary traffic management around the transition area (work area = green area) during the second stage of the works

**Figure 26).** During the second stage, the traffic has been deviated to the hard shoulder lane (around 4m width; giving access to the three interchanges and the two rest areas located along the work zone) and to a contraflow lane (around 3.25m width) separated to the opposite traffic flow by a continuous safety barrier. On both lanes, the speed along the work zone was limited to 70 km/h. The speed limit in the transition area (50m long opening in the central reserve) was 50km/h.

- A: transition area
- B: Hard shoulder lane
- C: Contraflow lane

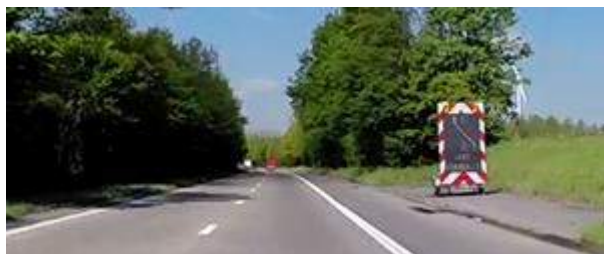
- A15/E42 – To Sambreville - KP 42.15 for Road user information about the road works, incidents and rerouting;

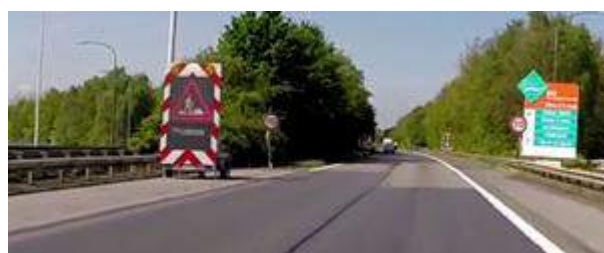
- A15/E42 – To Sambreville - KP 47.95 (close to the transition area) for Traffic management ;

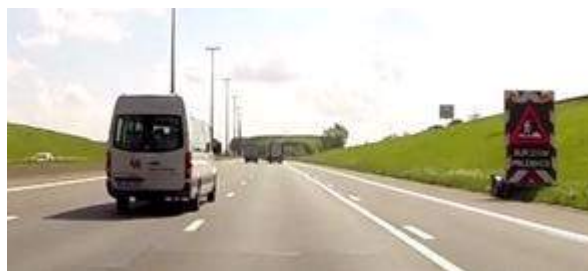
- A15/E42 – To Daussooux - KP 77.5 for Road user information about the road works, incidents and rerouting;

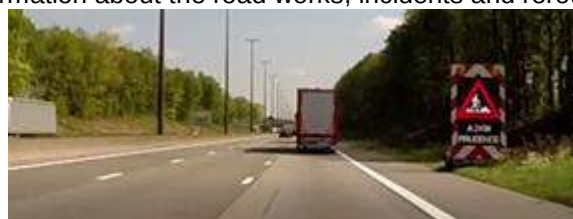
- A15/E42 – To Daussooux - KP 71.8 (close to the transition area) for Road user information about the road works, incidents and rerouting;

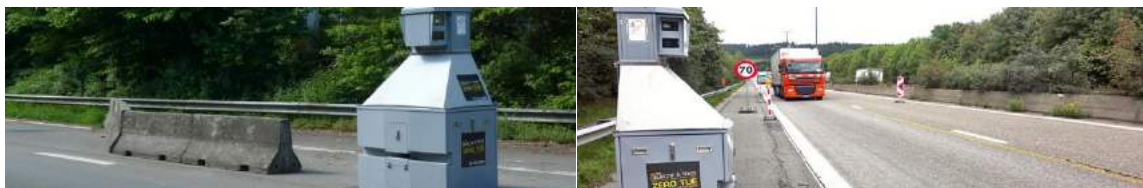
**Figure 29:** Example of an installation of an automated Speed Camera (source: [www.securoad.be](http://www.securoad.be))

Since some years, automatic speed cameras (**Figure 29**) are deployed on major road works carried out along Belgian motorways. These (semi-mobile) systems are installed for one or several weeks (consecutive or not) and control all the passing traffic. Such a system has been in operation for several weeks along the A15/E42, as shown on the table below (chapter 3.4.3.3).

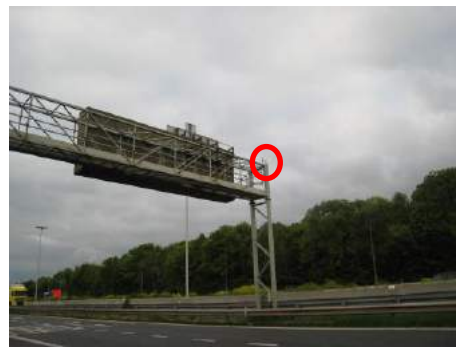
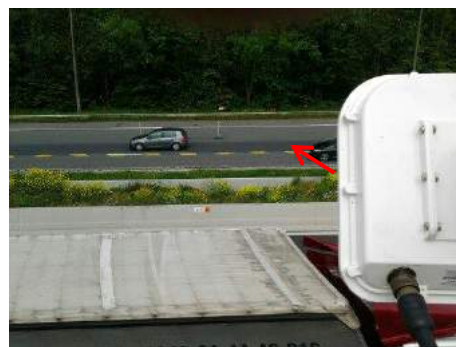
**Figure 30:** Wavetrax fixed on a gantry at KM 49,1 (200m before crossing the central reserve)

Being specifically acquired for the ASAP project, the A15/E42 site has been the first test site for the BRRC Wavetrax sensor and various problems related to the installation conditions and the power consumption have arisen.

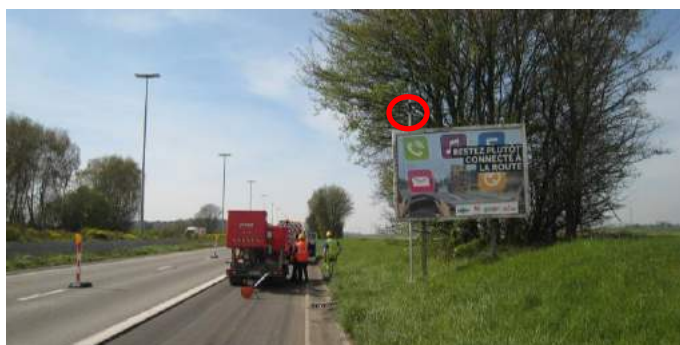
TMS-SA along Hard-shoulder PK 57.35

- Three portable (single lane) Doppler radars ([type TMS-SA from Icoms Detection](#)) owned and operated by the Walloon road authority.

These devices were installed all along the monitoring period. The only gaps in the data sets correspond to the time necessary to reload the batteries.

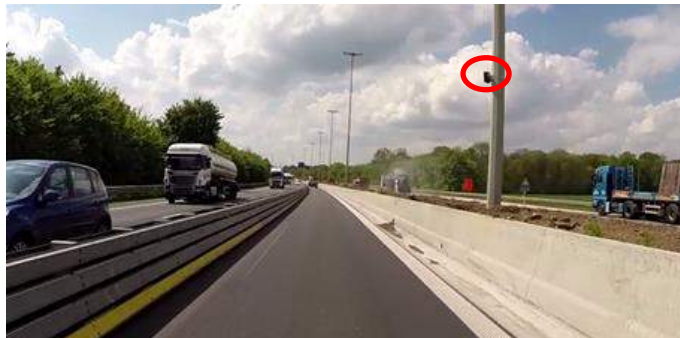
**Figure 31:** Location of portable (single lane) Doppler radars

TMS-SA along Hard-shoulder PK 59.35

TMS-SA along Contraflow PK 53.3

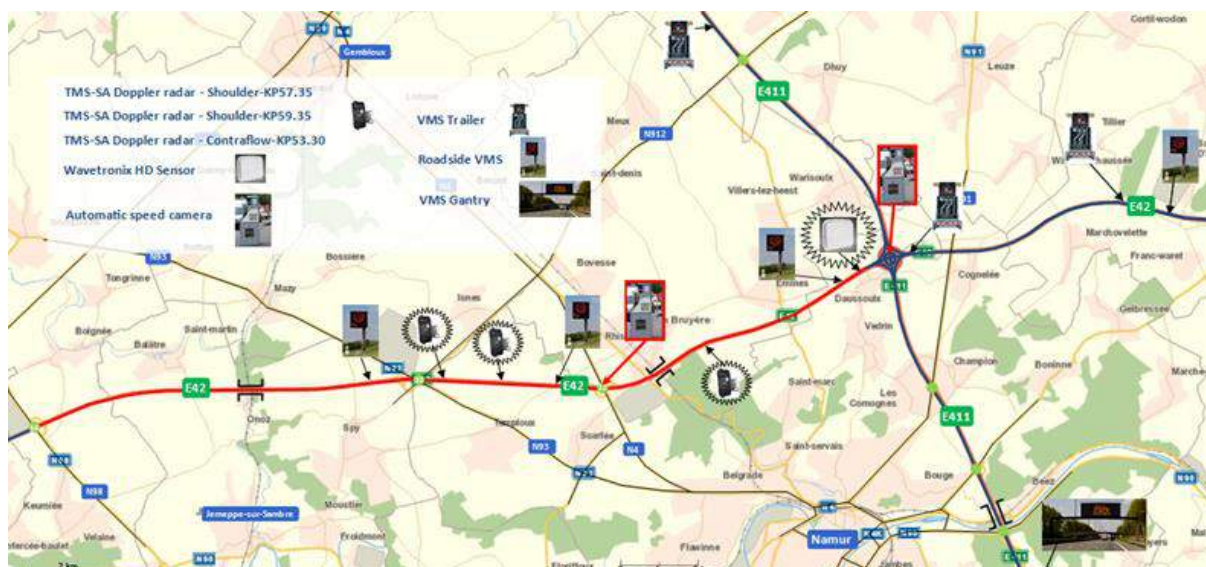
**Figure 32:** A15/E42 Road works - Equipment location scheme

These locations were decided in an early stage based on the idea that portable speed displays and trailers with a display of speed and car plate number would be available for testing. Speed monitoring devices were supposed to be located 300m after these displays or trailers for which suitable locations were identified. Unfortunately these systems, property of the road authority, were finally not available during the speed monitoring campaign

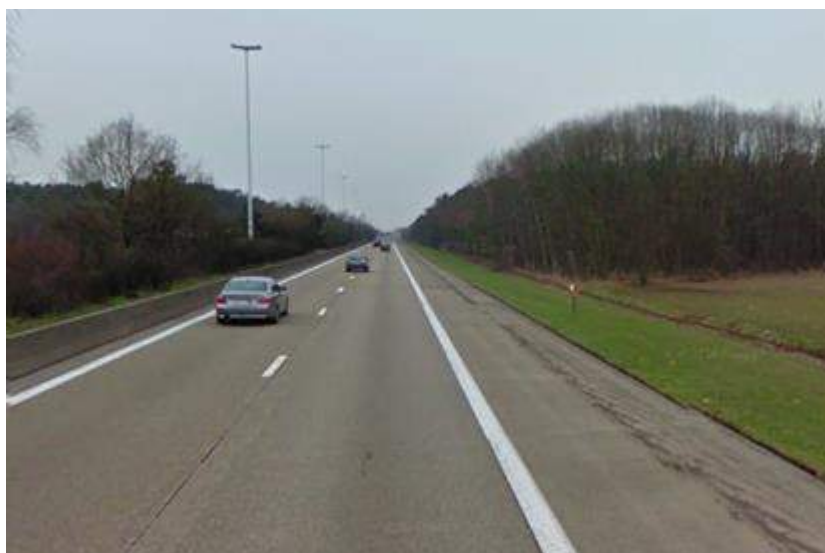
**Figure 35:** View of the A21/E34 (between Zoersel & Oelegem) before the 2014 works (structure rehabilitation)

The A21/E34 motorway was built in the early seventies and is composed of 2 lanes (+ a hard shoulder) in each direction (**Figure 35**). A structural rehabilitation of the section Zoersel-Oelegem has been scheduled for 2014.

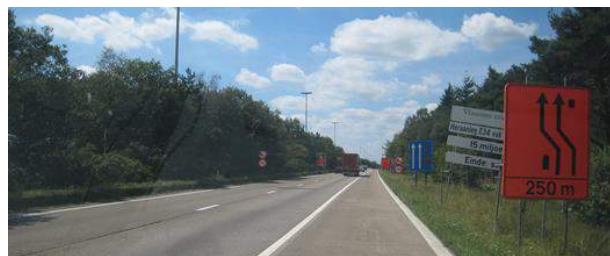
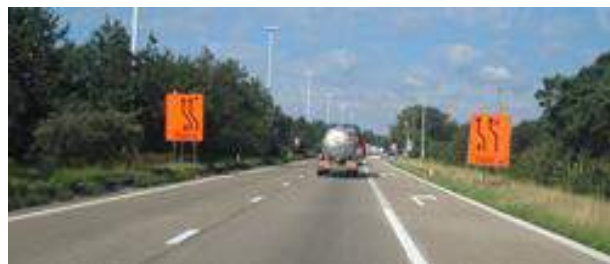
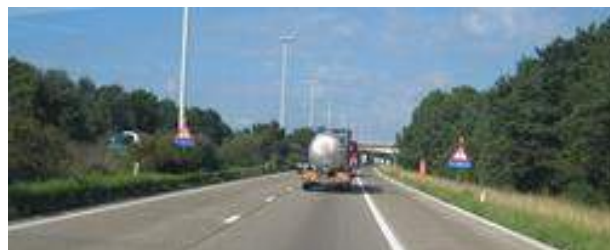
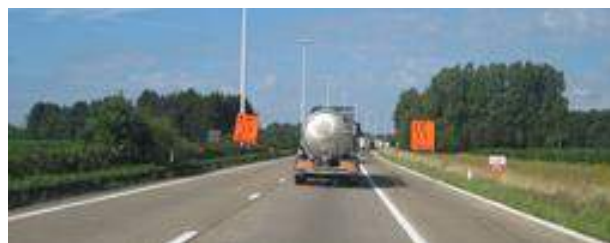
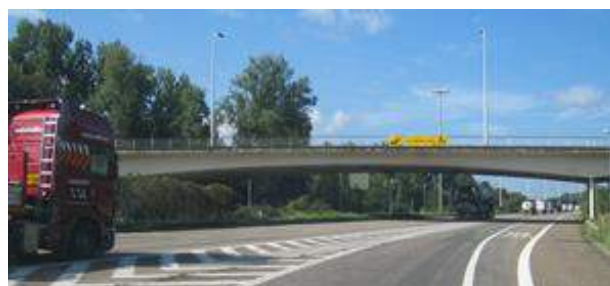
Figure 38: A21/E34 - Road work signing scheme

Consequently the design of the transition area has been adapted (longer transition, softer deviation angle) to provide safe traffic condition. In particular the opening of the central reserve has been enlarged to around 150m. This testing site therefore provides a very interesting showcase situation.

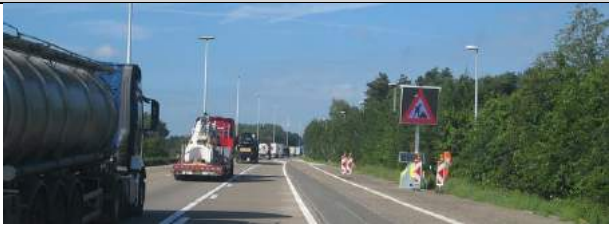
| KP (km) | Distance from a reference Point | Road sign, marking & equipment (Stage 1) | Type |
|---|---|---|---|
| 27.40 | - 4450m | | Road user warning – Road work ahead |

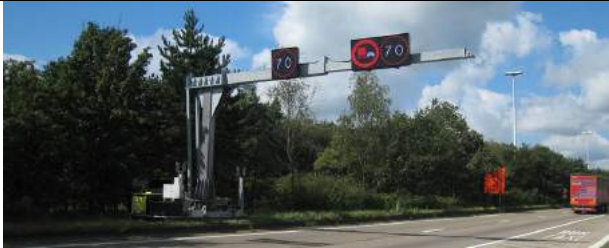
| KP (km) | Distance from a reference Point | Road sign, marking & equipment (Stage 1) | Type |
|---|---|---|---|
| 23.20 | - 250m | | Remind Speed limit and overtaking restriction (temporary gantry) |

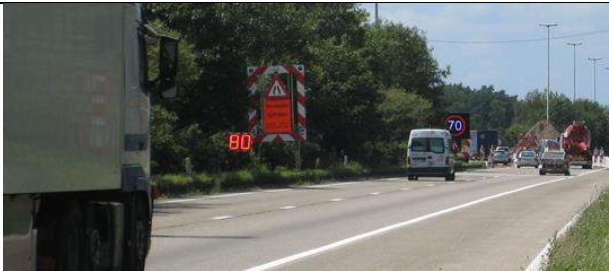
| KP (km) | Distance from a reference Point | Road sign, marking & equipment (Stage 1) | Type |
|---|---|---|---|
| 23.10 | - 150m | | Dynamic Speed Display |

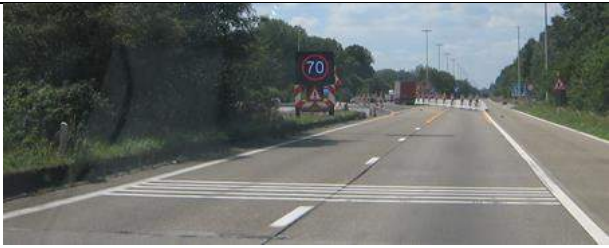
| KP (km) | Distance from a reference Point | Road sign, marking & equipment (Stage 1) | Type |
|---|---|---|---|
| 23.00 | - 50m | | Transversal Rumble strips |

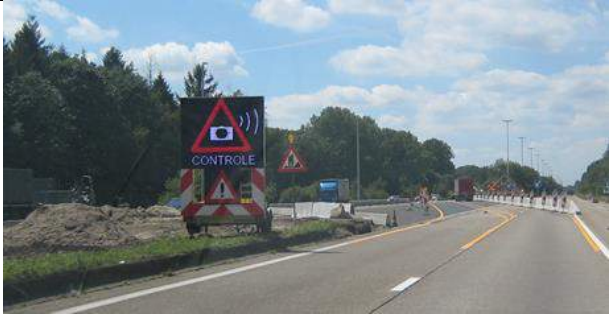
| KP (km) | Distance from a reference Point | Road sign, marking & equipment (Stage 1) | Type |
|---|---|---|---|
| 22.95 | 0 m | | Remind Speed limit and Warning about possible Speed enforcement (mobile VMS trailer) |

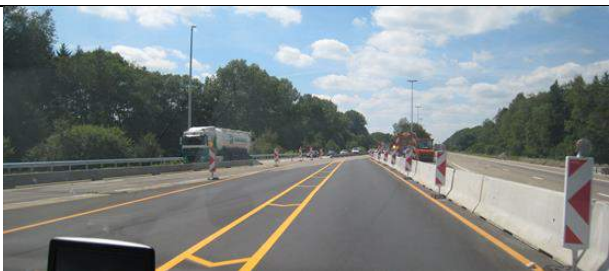
| 22,90 | Crossover | | Two adjacent lanes separated by a 1m wide neutral area) |

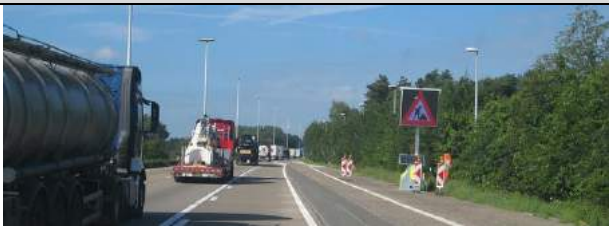
| 22,90 | Crossover | | Two adjacent lanes separated by a 1m wide neutral area) |
|---|---|---|---|
| 27.40 | - 4450m | | Road user warning – Road work ahead |

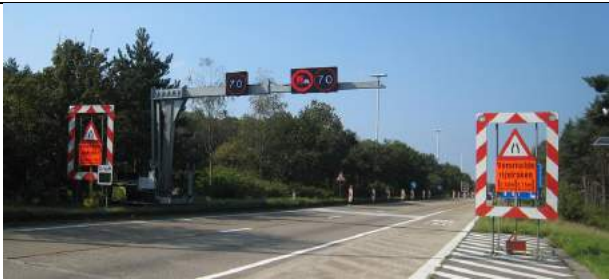
| 22,90 | Crossover | | Two adjacent lanes separated by a 1m wide neutral area) |
|---|---|---|---|
| 23.20 | - 250m | | Remind Speed limit and overtaking restriction + Dynamic Speed Display & Transversal Rumble strips |

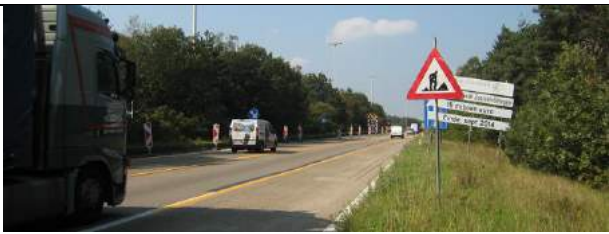
| 22,90 | Crossover | | Two adjacent lanes separated by a 1m wide neutral area) |
|---|---|---|---|
| 23.15 | 0m (Lane deviation) | | Two adjacent lanes separated by a 1m wide neutral area) |

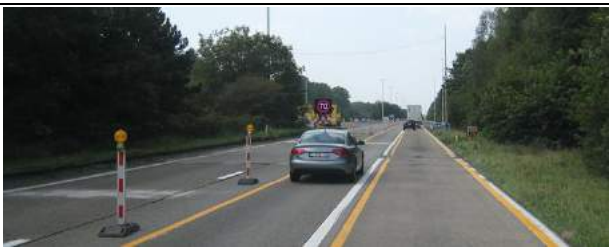
| 22,90 | Crossover | | Two adjacent lanes separated by a 1m wide neutral area) |
|---|---|---|---|
| 22.95 | +200m | | Remind Speed limit and Warning about possible Speed enforcement (mobile VMS trailer) |

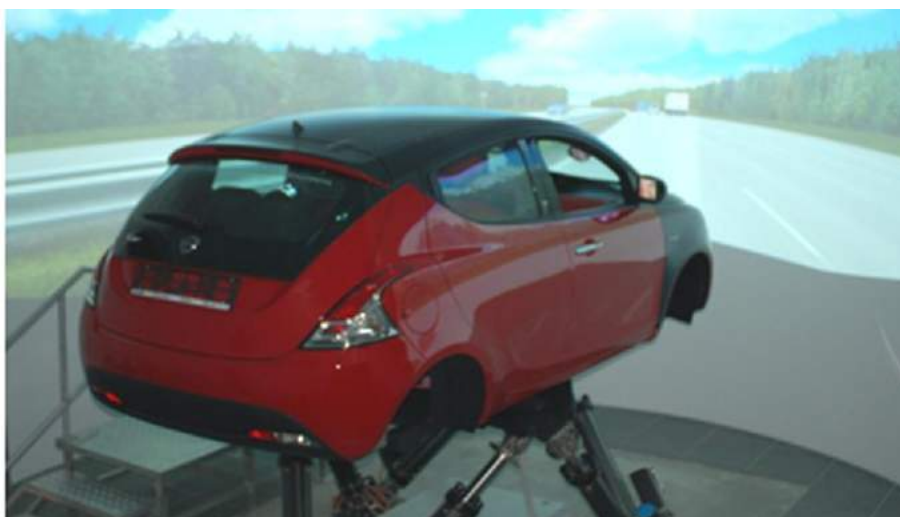
**Figure 41:** The dynamic driving simulator at the University of Florence

The driving simulator used for the tests is one of the most advanced available in Italy, equipped with a full scale vehicle (Lancia Ypsilon, **Figure 41**) fitted on a 6 degrees of freedom Stewart's platform, allowing roll, yaw and pitch.

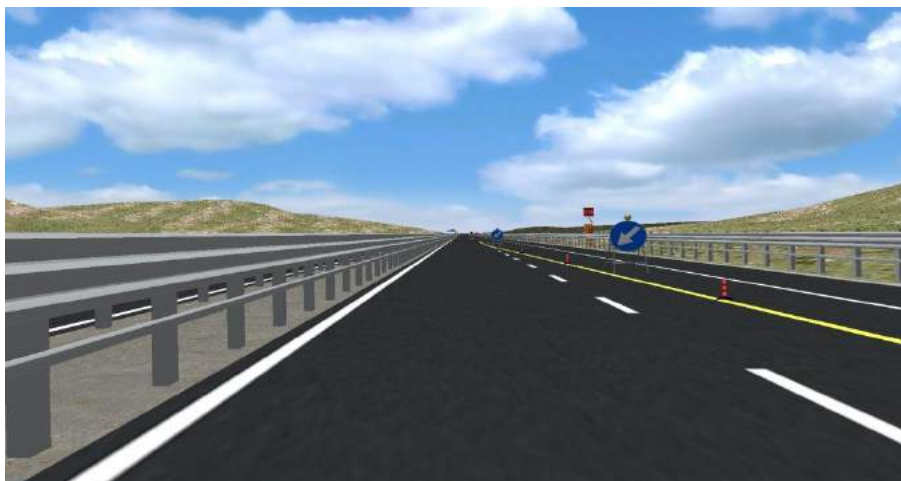
**Figure 43:** The transition area as seen by the driving simulator participants

Approximately 90 m after the “right lane closure” signs there is the transition area, which consists of a taper (realized with delineators and “keep left” signs) that close the right lane over a length of about 108 m followed by a section with a single lane approximately 250 m long (**Figure 43**).

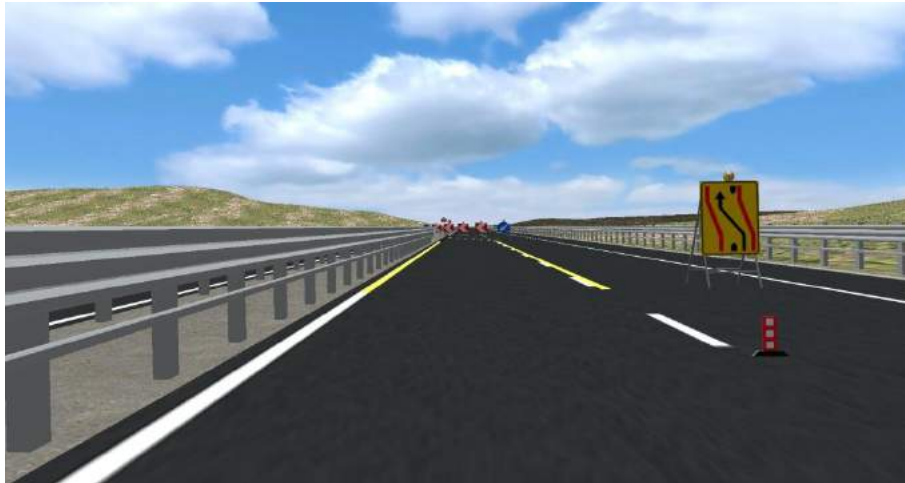
**Figure 44:** The “carriageway closure” sign in approach to the “entrance by-pass”

In this section the speed limit is reduced to 40 km/h. The speed limit sign is placed about 100 m before the end of the transition area, followed by the “carriageway closure” sign placed 36 m before the “entrance by-pass” (**Figure 44**), that shifts the traffic flow in the activity area across the median. The median opening is 40 m wide.

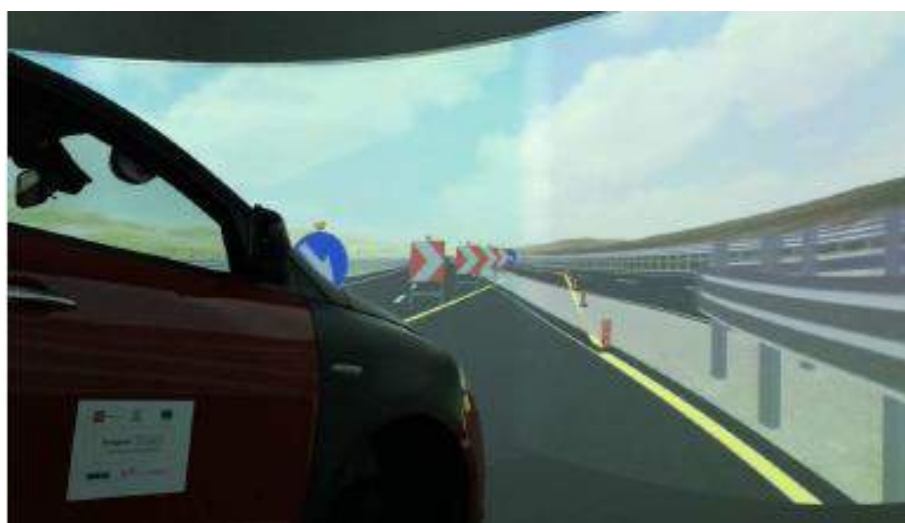
**Figure 45:** The “exit by-pass” experienced by the participants

The termination area includes the taper to direct the traffic back into travel roadway after traversing the activity area. This area ends with the “End of road work” sign, placed 48 m after the exit by-pass.

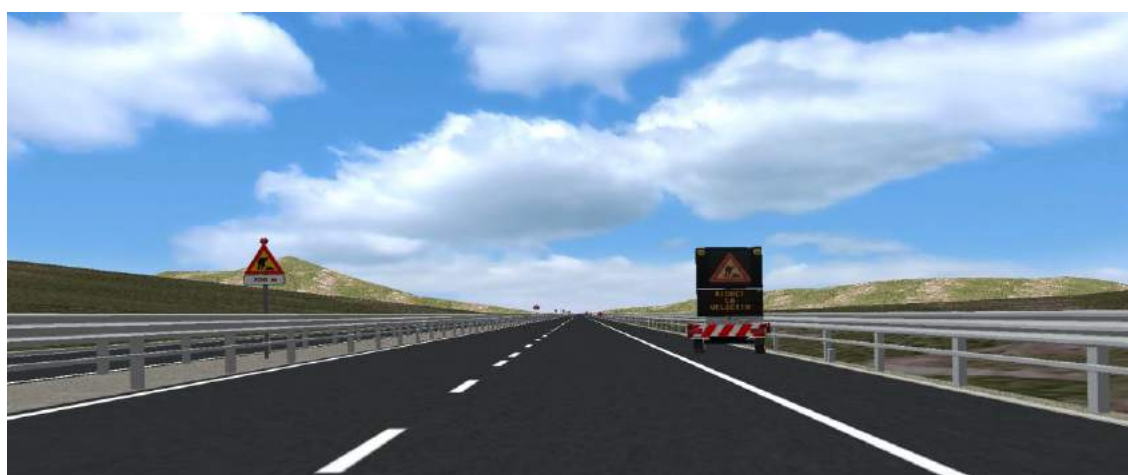
Figure 47: Picture of the VMS sign displayed in the simulator

The message implemented in the VMS sign reads “Riduci la velocità” (“Reduce the speed” in Italian, Figure 47).

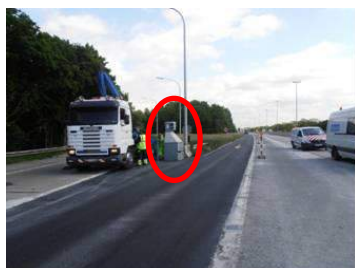
## 10. Automated speed camera

An automated speed camera has been deployed on-site during one of the speed monitoring campaign carried out in Belgium (cf. chapter 3.4.2.2). The camera consists in a semi mobile system installed on a fixed location along the road works, for several days. It controls speeds of all the detected vehicles and record information about over-speeding ones. This information is automatically forwarded to the Police who deliver fines.

Road users were informed by a permanent sign about the likeliness of speed enforcement. Some comparative analysis between reference and deployment period were made during WP4.
