## **CEDR Transnational Road Research Programme Call 2013: Energy Efficiency – Materials and Technology**

# **CONSISTEND: A tool to assess the impact of construction process quality on the performance of pavements and its implementation in tenders**

## **WP4- Report 4a: Report on the demonstration projects**

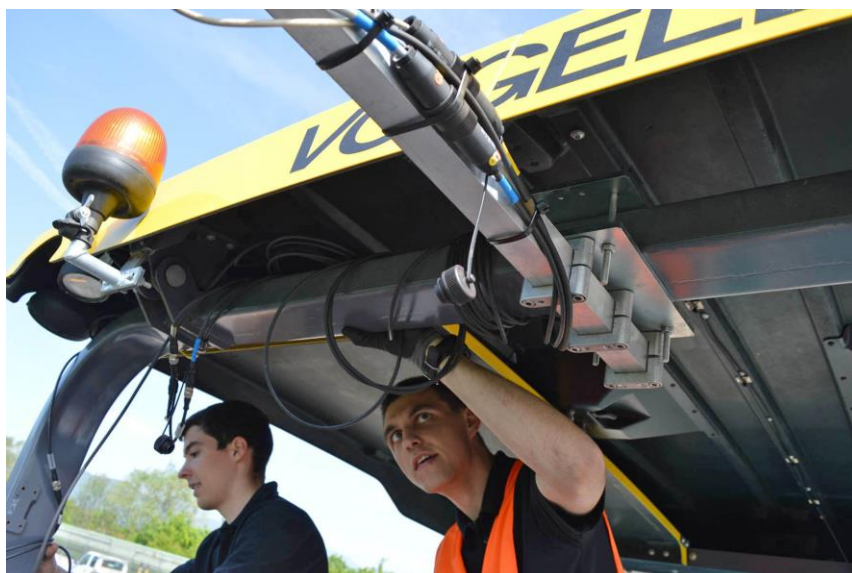
Figure 2: Mounting of the equipment on paver

Apart from the usual QC testing scope, new innovative techniques were used to monitor the paving process on the investigated motorway section. For CONSISTEND project additional equipment was rented from MOBA Mobile Automation AG to monitor the laying process for the top layer. Mounting of the equipment on the paver by producer's experts is shown in figures 1, 2 and 3.

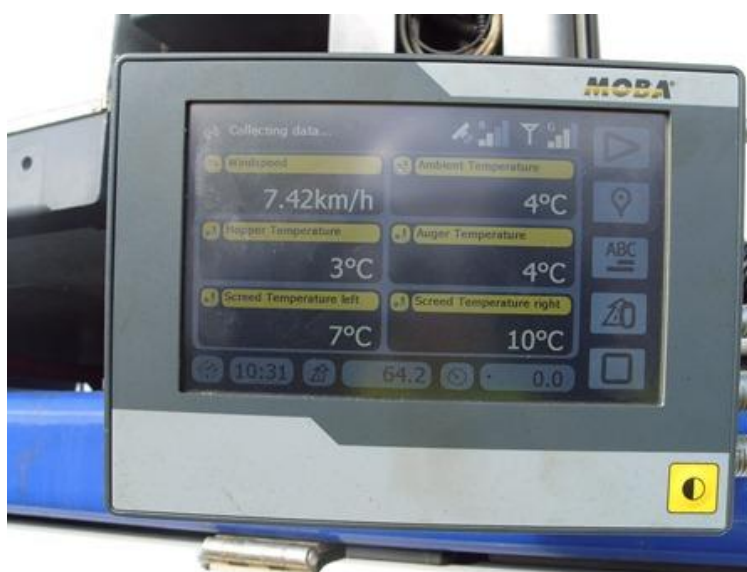
Figure 22: Digital screen

Figure 22 shows the digital screen used to enable the operatives to monitor the readings and ensures that the laying and material parameters are met. Figure 23 shows the digital screen mounted on the paving machine.

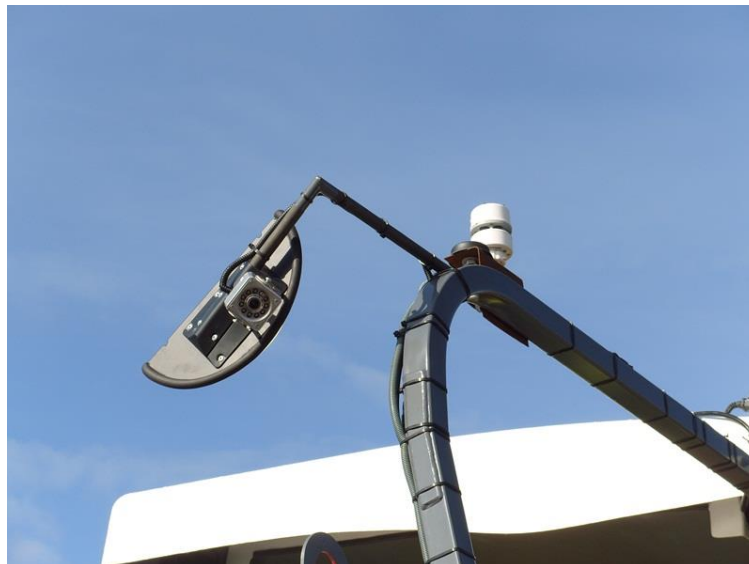
**Figure 24: GPS antennae**

Figure 24 shows the GPS antennae mounted on the roof of the paver together with the wind speed and air temperature measurement equipment.
